Replacement of power transistors SRFH1008 and MRF455

Introduction

This service bulletin affects the users of transceivers with power amplifier (PA) output transistors SRFH1008 or MRF455. There are two transistors (matching pair) on each PA PCB. The following transceivers are affected:

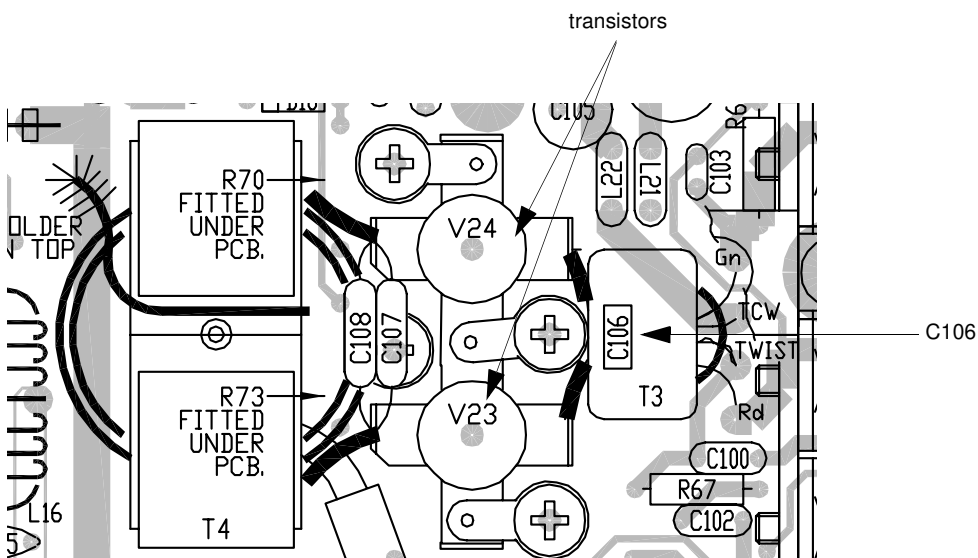
Figure 1: Power amplifier PCB for the 93xx series/9780 and LP transceivers

- Remove the two faulty transistors from the PA PCB (see Figure 1).

- Replace C106 with a capacitor that has a value of 470 pf.

Later model 93xx series/9780 PAs (Codan part number 08-04963-xxx) may already have the 470 pf capacitor in place. If you are unsure of the value of C106, it is recommended you replace it with a 470 pf capacitor as a precaution.

- Replace the transistors with MS1253-CDN.
- Continue from [page 3, Adjusting the driver bias for power amplifiers in 93xx series/9780 and LP transceivers.](#)

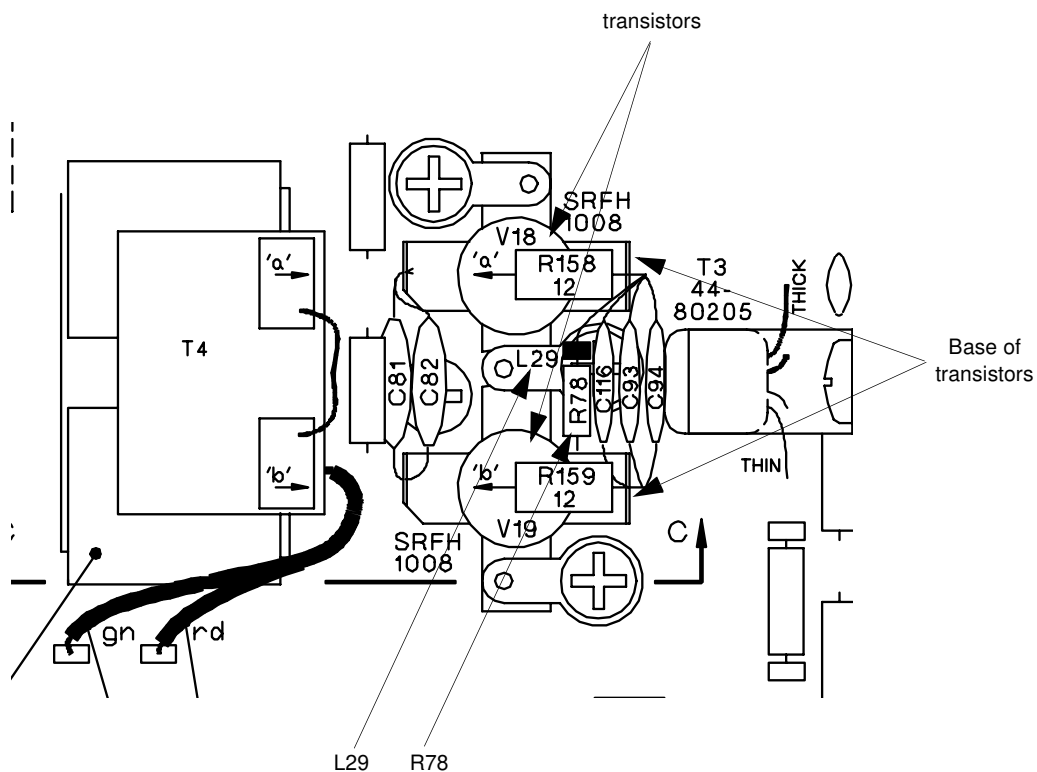
Figure 2: Power amplifier PCB for the 85xx series/9313/9480 transceivers

- Check if there is a resistor/choke (R78/L29) across the base of both transistors on the PA PCB (Codan part number 08-03743-xxx) (see Figure 2).

If R78/L29 is not present, it must be fitted.

Without the resistor/choke in place, spurious oscillations at approximately 4 MHz occur. The resistor/choke network consists of a:

- ↪ • 12 Ω ¼ W 5% resistor
- ferrite bead placed on one leg of the resistor with a small amount of silastic to stop any movement

- Replace the transistors with MS1253-CDN (see Figure 2).
- Continue from [page 5, Adjusting the output bias in all transceivers](#).
