KWM-380

Service Bulletins

AC-3803 CONTROL INTERFACE KIT (641-7150-001)
CONTROL INTERFACE CIRCUIT CARD (638-6910-001)

SERVICE BULLETIN NO 1

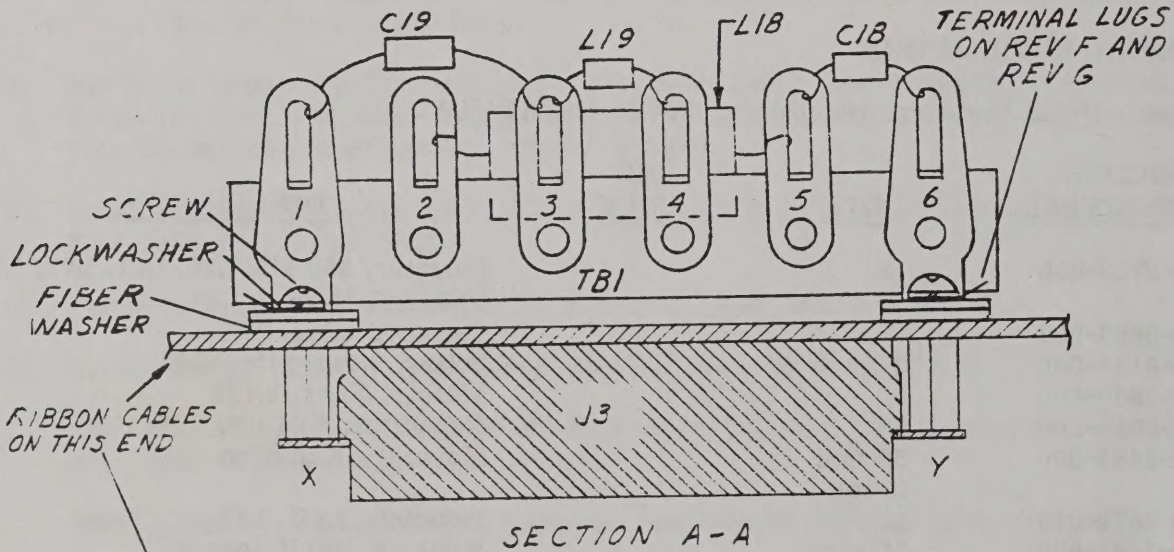
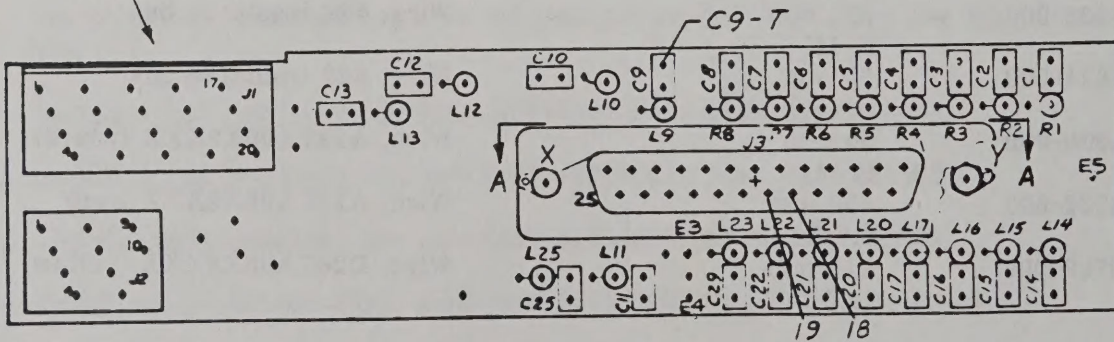
Control Interface Circuit Card Assembly, REV H
Figure 2

Rfi filtering is improved by changing ground paths on the circuit card to increase the effectiveness of the bypass capacitors. More ground paths are provided to reduce inductance. This will help prevent transmitted rf from getting back into the radio causing transmit inhibit condition.

- A. Rfi resistors are changed to inductors in the coupler interface lines to reduce the voltage drop.
- B. Two new functions, +14 V dc and ALC, are added. Inductors and capacitors are added to filter the new lines.

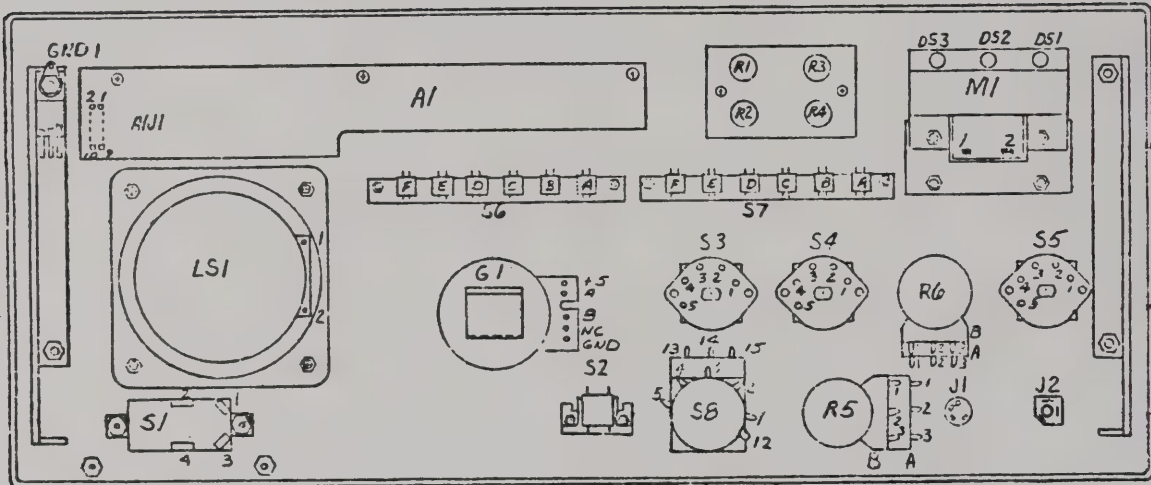
KWM-380/HF-380 Front Panel, Rear View
Figure 1

The purpose of this service bulletin is to correct a transmit hum caused by a ground loop between the front panel and the receiver/exciter card ground plane.

This modification replaces the mic jack (J2) with a jack that has an insulated sleeve contact to break the ground loop.

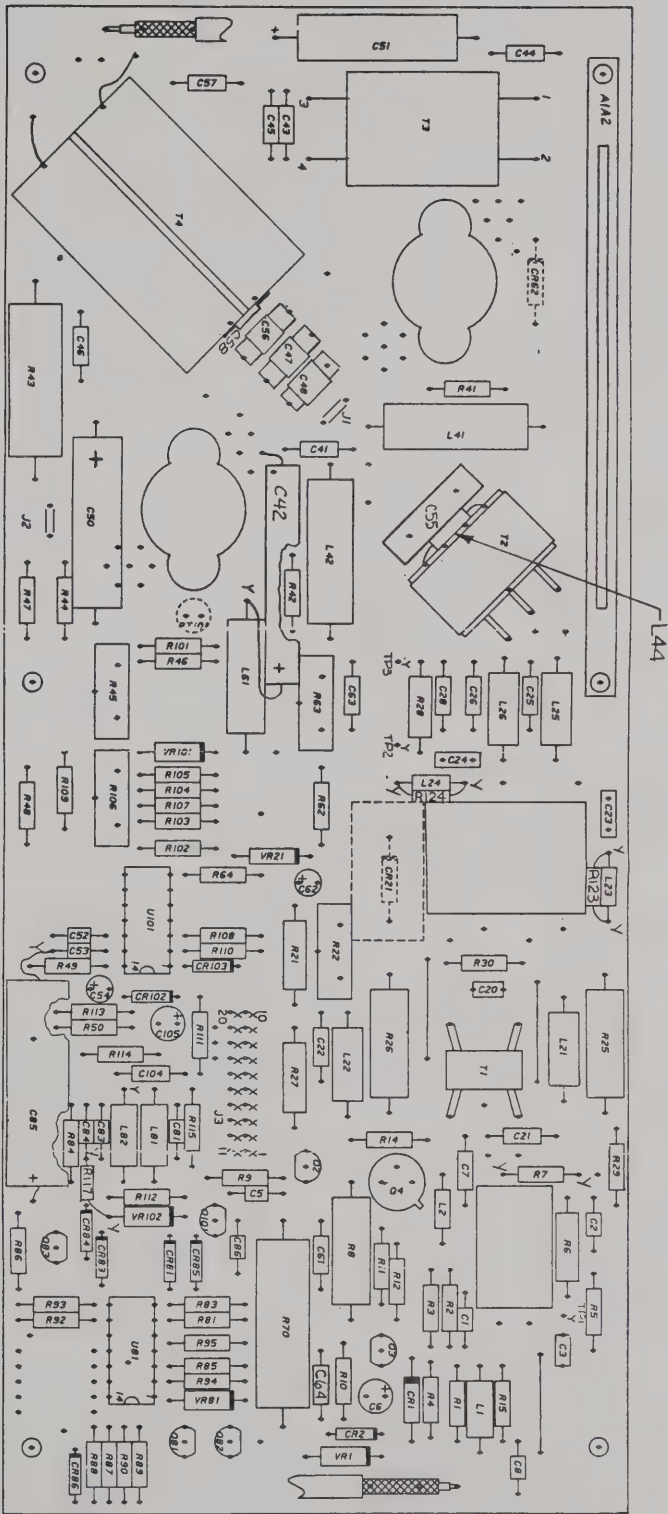
Power Amplifier A1A1,
 After Modification
 Figure 1 (Sheet 2)

NOTE: LEADS FROM T2 AND T3 MUST BE CAREFULLY POSITIONED AS SHOWN TO PREVENT DESTRUCTIVE OSCILLATION.

- K. Install 100 ohm resistor R124 (745-1310-000) in parallel with L24. Wrap the resistor leads around the coil leads and solder.
- L. Examine transistors Q41A/B and resistor R7. If Q41 was manufactured by Motorola, the value of R7 should be 15 ohms. If Q41 was manufactured by CTC, the value of R7 should be 27 ohms. If it is necessary to replace R7, cut the resistor leads close to component body, leaving the leads soldered into the circuit card. Install the new resistor (15 ohms, 745-0683-000 or 27 ohms, 745-0692-000), attaching the leads to the old resistor leads.

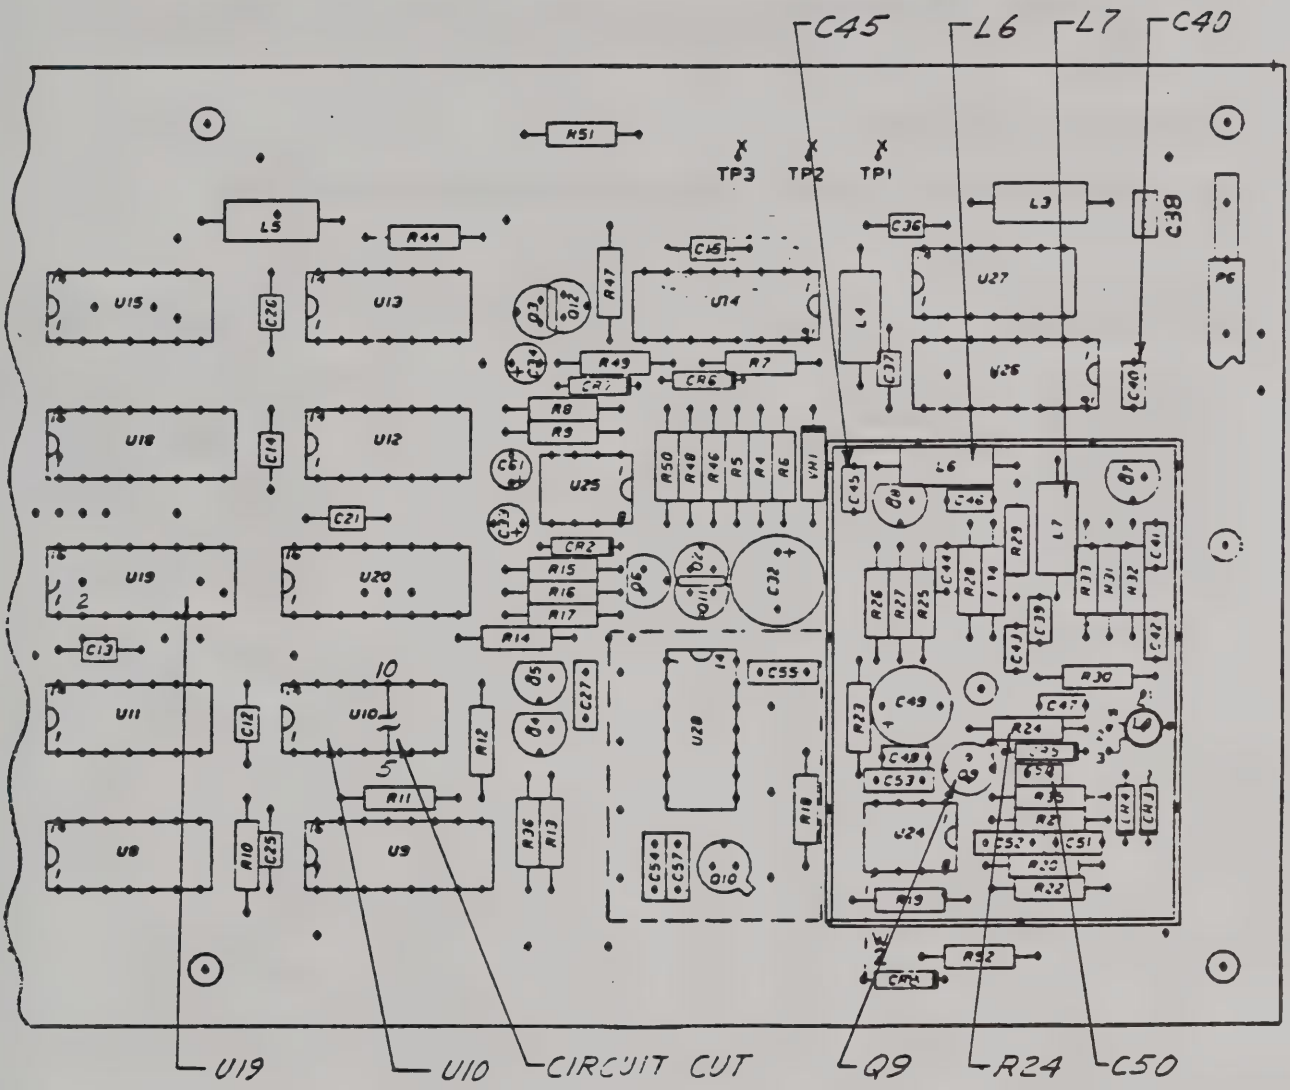
P/O Synthesizer Variable Reference Frequency Loop A5A2
Figure 1

A frequency warble may occur at certain frequencies in some radios. The warble will usually occur at the top end of each 1 MHz band. The problem has been traced to two integrated circuits on synthesizer variable reference frequency loop A5A2. When U14 and U26 are at the low end of their specified parameters, a low rf input may cause them to miscount.
