# YAESU FP707-FP757

## PSU REPAIR

— "another" design issue

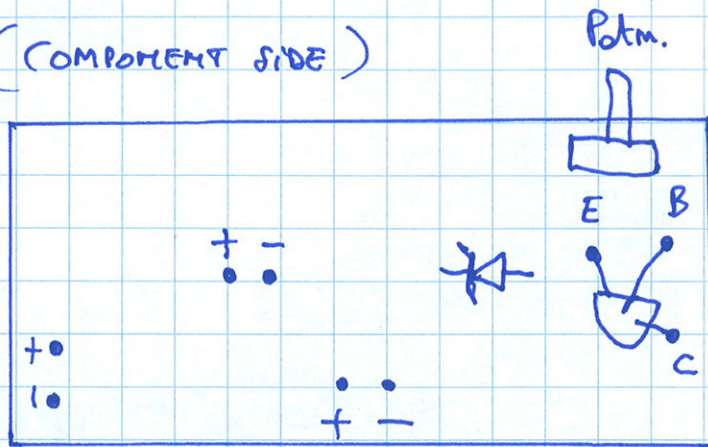
(COMPONENT SIDE)

Q103 UNDERSIZED

(SYMPTOM: 22V output  
in stead of 13,8V)

"WAS" 2S4550

↳ fails regularly!

→ do NOT replace by "universal" NPN like BC558

→ too weak, needs HIGH  $I_c$  NPN like BC369

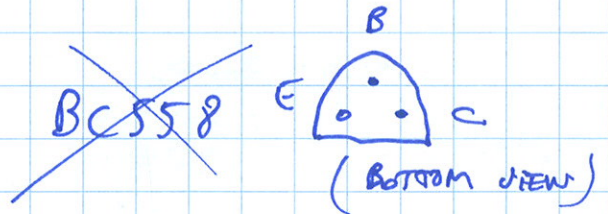
BC369

→ ~~PNP BC558~~  
> 300 mA  $I_{C_{max}}$

(bend middle collector leg to other side to fit PCB)
