# VR-004

## Vintage Radio Application Note

# RECONDITIONING THE HEATHKIT MODEL TT-1/TT-1A TUBE TESTER

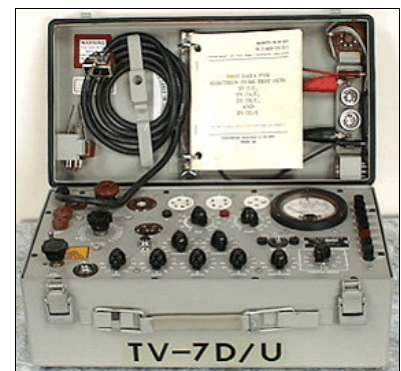
**Figure 1 - TV-7D Tube Tester**

In the fullness of time, I learned that the TV-7 is a rugged, time-honored and field-tested unit with an excellent track record. On the negative side, however, this unit was designed primarily for compactness and portability. This in itself is not detrimental, but my concern was that a unit designed primarily for compactness might suffer from some design trade-offs as a price to obtain that compactness.

The other issue that concerned me was that of restorability and maintainability. A tube tester as compact as the TV-7 is difficult to work on due to its very high component density. Since

the very newest TV-7 is likely over 30 years old, restoration, maintenance, and repair would likely be required. My preference therefore was for a larger unit whose components were more accessible and easier to work on. Even so, for someone less concerned about maintenance issues, a working TV-7 in good condition would be an excellent choice (although a clean, working unit would likely cost up to \$1,000).

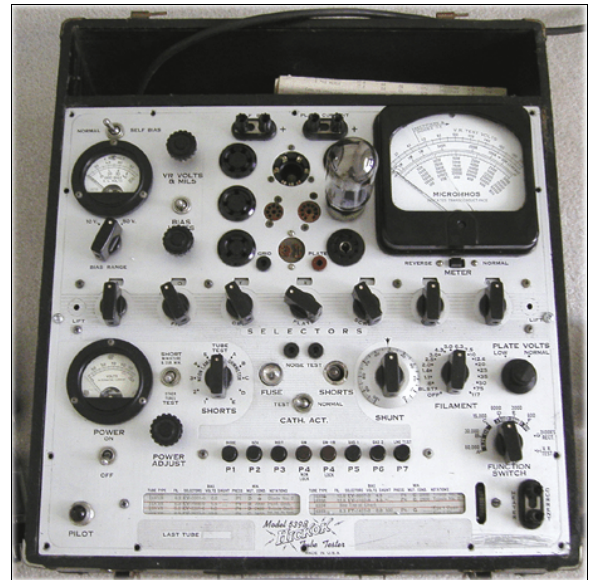
**Figure 2 - Hickock 539C Tube Tester**

Another model that is well thought of by vintage radio enthusiasts is the Hickock 539C (see Figure 2). Since this unit was not designed primarily for compactness, it is very feature-rich (even to the point of having multiple meters). Also, since this unit is much larger than the TV-7, it overcomes most of the TV-7 component accessibility and maintenance issues. Like the TV-7, however, a clean, working 539C in good condition would likely cost up to \$1,000.

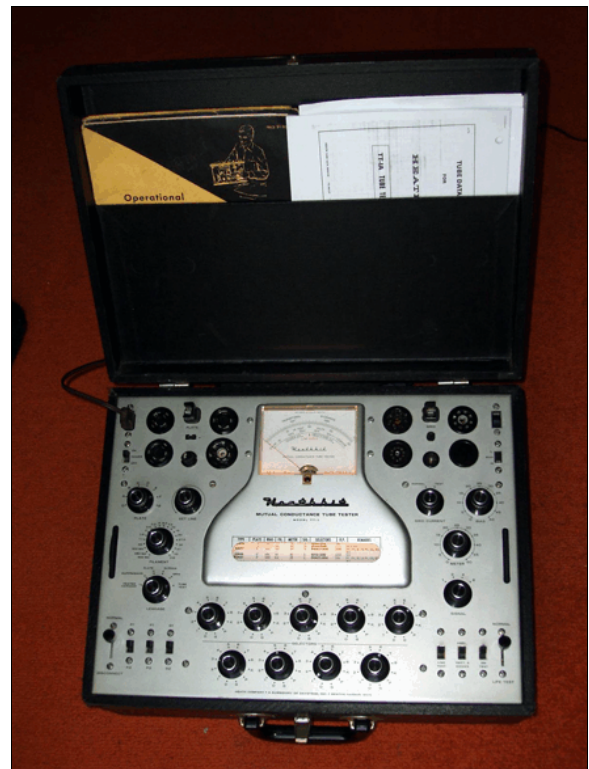
**Figure 3 - Heathkit TT-1 Tube Tester  
(taken from Kent Nickerson's website)**

The Heathkit TT-1 (see Figure 3) is more similar to the 539C than the TV-7. Although the TT-1 is less elaborate than the 539C, it is nonetheless a fine instrument that can be relied upon to test tubes with reasonable accuracy. My understanding is that the TT-1 design is very closely based on that of the Weston 981. The TT-1 was first sold in 1960 as Heathkit's flagship tube tester and remained in production well into the '70s.

The most positive aspect of the TT-1 in my mind is that since it was designed to be built as a kit, its components are inherently accessible and the unit is relatively easy to maintain and repair. Also, Heathkit was world-famous for its well-written and well-illustrated documentation, and the TT-1 assembly and operational manuals fully meet these high standards.

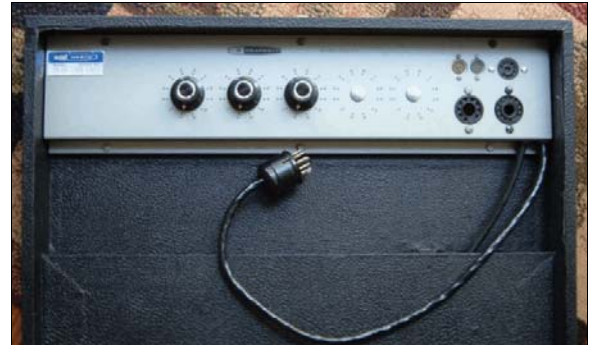
**Figure 4 - TTA-1-1 Supplemental Tube Socket Adaptor Assembly (for TT-1A)**

The TT-1A is an expanded version of the original TT-1 that includes the TTA-1-1 supplemental socket adaptor assembly (see Figure 4). This adaptor (which is installed in the lid of TT-1A protective wooden case) was introduced in 1962 to accommodate newer vacuum tubes developed after the introduction of the original TT-1. These newer tubes include miniature Nuvistors and 12-pin Compactrons.

The TTA-1-1 was also sold separately so that TT-1 owners could upgrade their existing units to TT-1As. It is likely, however, that most vintage radio enthusiasts would not need the TTA-1-1.

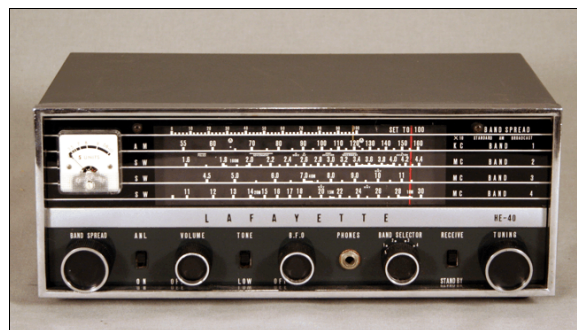
**Figure 5 - Lafayette Radio HE-40  
540 kHz-30 MHz “All-American Five”  
AM/Shortwave Receiver**

The most prominent equipment that employed this technique was the “All-American Five”. The All-American Five was a generic category of low-cost AM broadcast superheterodyne receivers employing five tubes with series-string filaments. There were many manufacturers and models of these radios, which were mass produced in very large quantities from the mid-1930s through the early-1960s (both in the USA and overseas). A typical tube line-up for the later models using 7- and 9-pin miniature tubes was a 12BE6 (pentagrid converter), 12BA6 (IF amplifier), 12AV6 (AM/AGC detector and audio preamplifier), 50C5 (audio output amplifier), and a 35W4 (half-wave power rectifier).

The final models eliminated the 35W4 (or other vacuum tube) rectifier in favor of a silicon diode (substituting an appropriate power resistor in place of the 35 volt filament). A typical later model (the Lafayette Radio HE-40 which was produced in the early 1960s) is illustrated in Figure 5. In addition to covering the 540-1600 kHz AM broadcast band, the HE-40 also covered the 1.6-30 MHz shortwave bands in three additional band-switched ranges. The HE-40 (built by Trio in Japan) was a copy of the Hallicrafters S-120. These units were nearly identical in appearance, but the HE-40 included an S-meter that the S-120 lacked. The HE-40 was among the best and most elaborate of the All-American Fives. Realistically speaking, however, although the All-American Fives were skillfully engineered, they were designed primarily for economy rather than performance. While they performed adequately for AM broadcast band reception, even the best of them were marginal performers in the shortwave bands (particularly above 10 MHz).

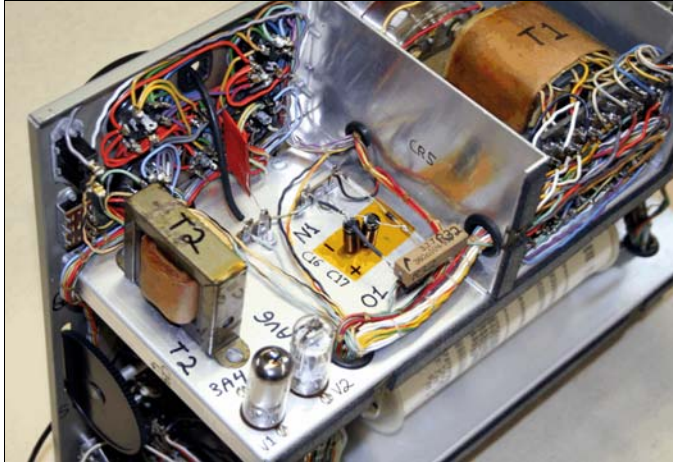
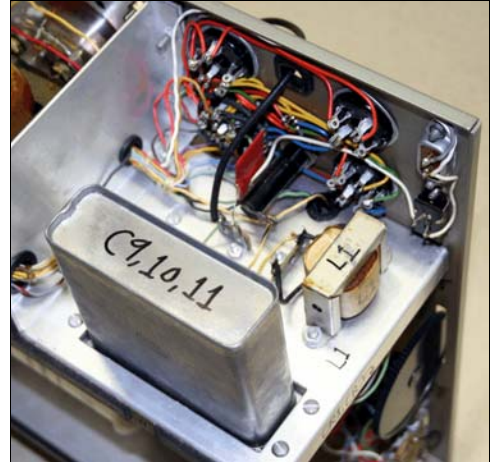
TT-1A chassis photos are presented below to help readers identify the substituted components and their locations.

In this Section, detailed procedures are presented to replace various TT-1 components following an initial inspection and evaluation. Upon completion, the unit is then run through the test and calibration procedures presented in the Heathkit TT-1 assembly manual. Chassis photos are presented in Appendix A to help readers identify the substituted components and their locations.
