Heathkit of the Month #84:
by Bob Eckweiler, AF6C

Heathkit V-6 VTVM Restoration Part I
“Siliconizing” the V-6 Selenium Rectifier
(Heathkit part # 57-1, Sarkes Tarzian Model 35)

Heathkit of the Month #86:
by Bob Eckweiler, AF6C

Heathkit V-6 VTVM Restoration Part II.

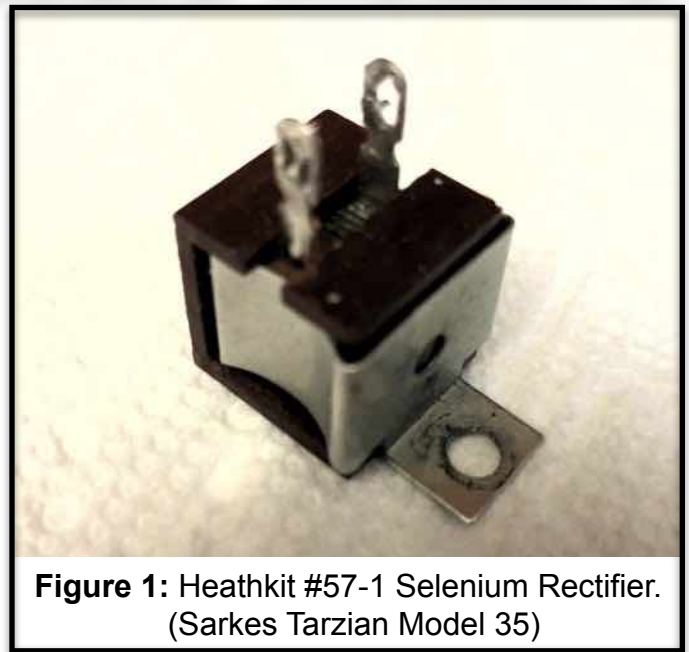
Figure 1: Heathkit #57-1 Selenium Rectifier.
(Sarkes Tarzian Model 35)

I didn't think I'd have a Heathkit article this month. However, while awaiting parts to arrive I decided to see if I could convert the #57-1 selenium rectifier to silicon (See figure 1) in the V-6 VTVM under restoration. It presented a bit of a challenge and one I was happy to undertake slowly, whenever I needed a break from the less exciting task of doing taxes. Now, all the parts I believe I need have arrived save one (one vendor sent me the wrong part and is resending a correct one).

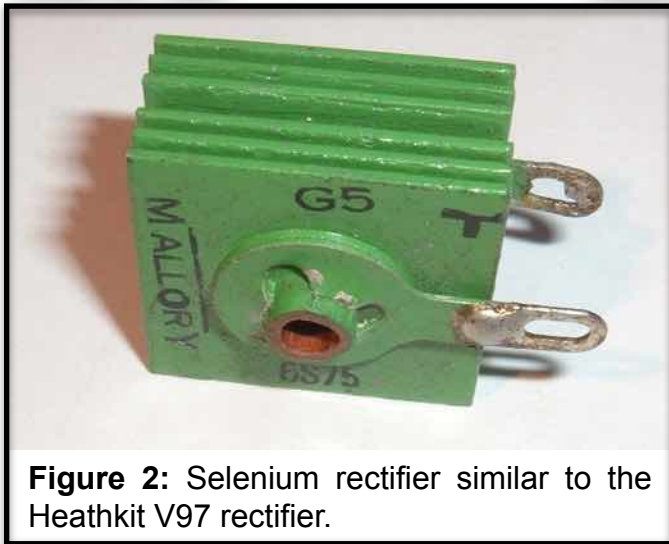
Figure 2: Selenium rectifier similar to the Heathkit V97 rectifier.

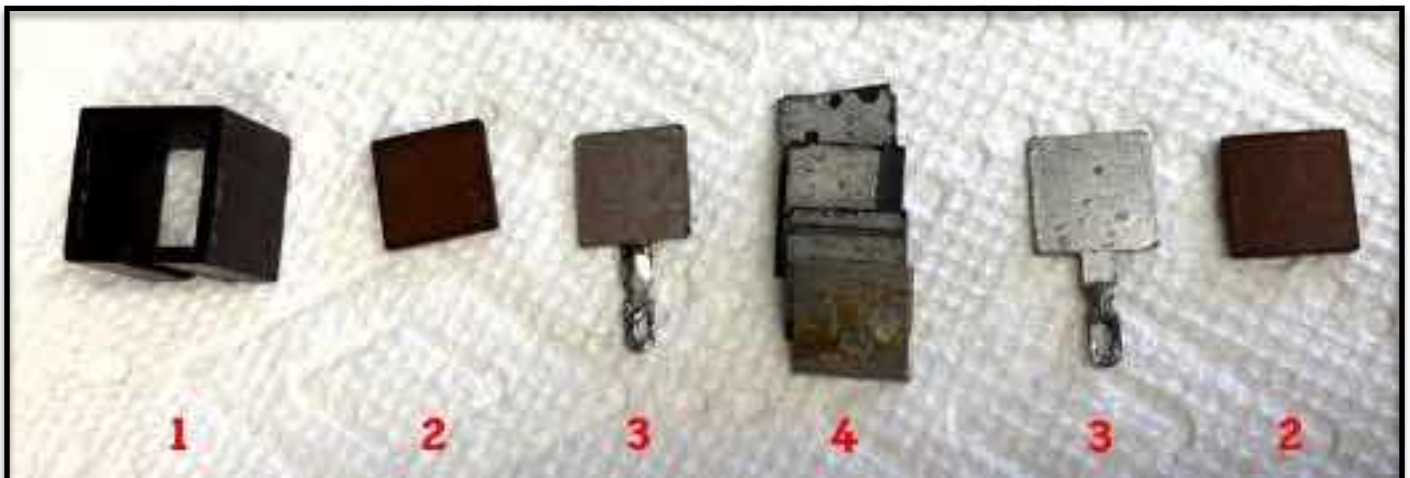
An examination of the 57-1 rectifier shows it is held together with a spring clip and easily disassembled into a phenolic housing, two phenolic end plates, two terminal end plates and a stack of selenium-coated plates (figure 3).

Figure 3: The disassembled 57-1 Rectifier.

- 1. Phenolic case
 - 2. Phenolic end plates
 - 3. Terminal End plates
 - 4. Selenium coated plates
- Not shown - Spring clamp with mounting tab (#5 in figure 4)

The selenium plates were wrapped and discarded as toxic waste. Selenium, in excess, is toxic so wash your hands well when you are done. Next, the two metal terminal end pieces were cleaned and a small hole drilled in the center of the large rectangular section of each plate. (a #55 drill - 0.052" dia. was used). The area around the holes were tinned on one side. The leads of a 1N4004 diode we're also tinned. The cathode end of the diode was then soldered through the hole in one terminal end plate (tinned side towards the diode cathode), and the lead trimmed flush to the plate. This cathode terminal should be marked as such with a felt-tip marker.

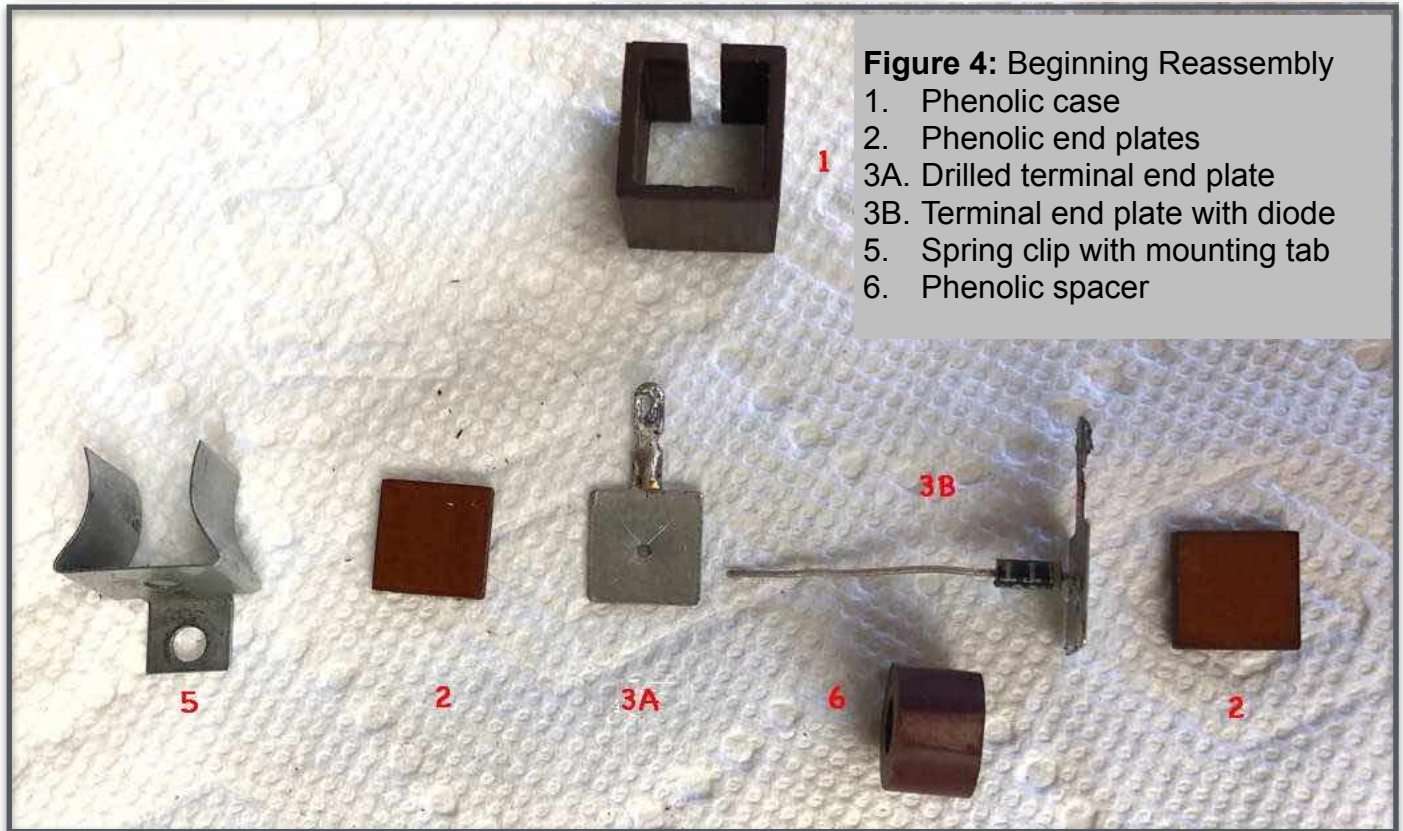
Figure 4: Beginning Reassembly
 1. Phenolic case
 2. Phenolic end plates
 3A. Drilled terminal end plate
 3B. Terminal end plate with diode
 5. Spring clip with mounting tab
 6. Phenolic spacer

A 1/2" diameter phenolic spacer, about 0.325" in length, was found in the junk box It just barely wouldn't slip into the phenolic case until four flats were ground 90° apart around the spacer. One phenolic end plate and the terminal end plate with the diode attached

placed into the spring clip with mounting tab. This has to be assembled so the cathode terminal end, with its lug pointing up, is towards you when the mounting clip is pointed to the right (See figures 4, 5, 6 and 7).

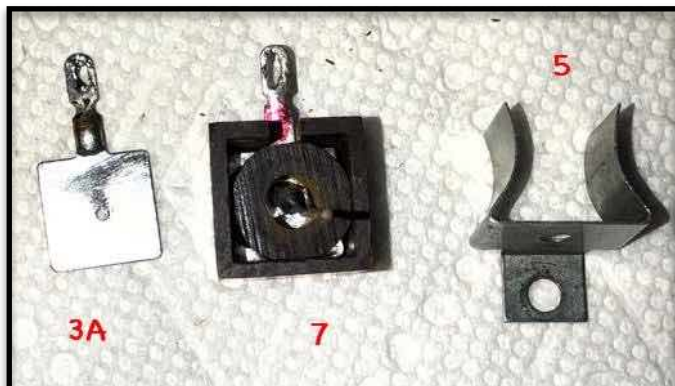
Figure 5: Partial Reassembly.
 3A. Drilled terminal end plate.
 5. Spring clip with mounting tab
 7. Assembly of:
 a. A phenolic end plate
 b. A end terminal plate with diode soldered on
 c. Phenolic case
 d. Phenolic spacer

were slid into the phenolic case. The spacer was then slid over the diode and the second terminal end plate was pressed flush to the phenolic spacer and soldered. If the diode lead was already tinned along with the side

of the terminal end plate that is towards the diode, the solder should be drawn into the hole with little solder remaining on the outer side. This diode lead is then also cut off flush to the terminal end plate. Finally the second phenolic end plate is placed above the top terminal plate and the whole assembly is

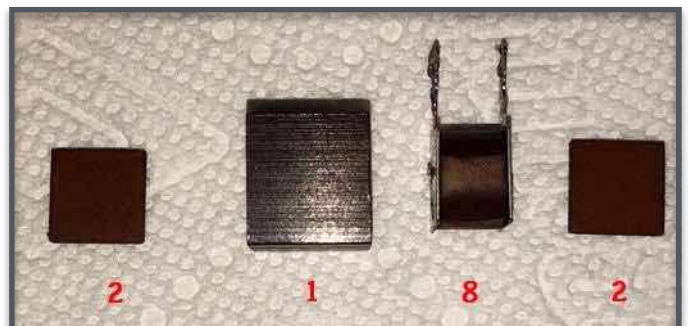
Figure 6: Ready for Final Assembly
 1. Phenolic case (slot up)
 2. Phenolic end plate
 8. Assembly of:
 a. two terminal end plates
 b. phenolic spacer
 c. 1N4004 diode (or equivalent)

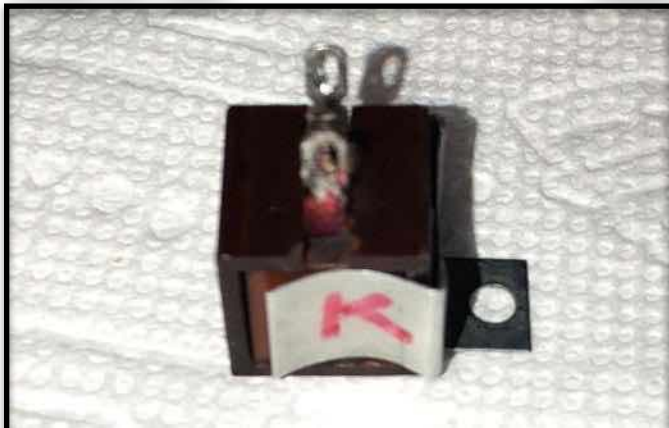
Figure 7: Completed Selenium Rectifier Converted to Silicon with Cathode Marked

Prior to installation in the V-6, the 'K' was cleaned off with alcohol, but the red marking on the cathode terminal stem was left on.

The result is a silicon 1N4004 rectifier diode mounted inside the case of the #57-1 selenium rectifier case. This diode should outlast the V-6 VTVM.

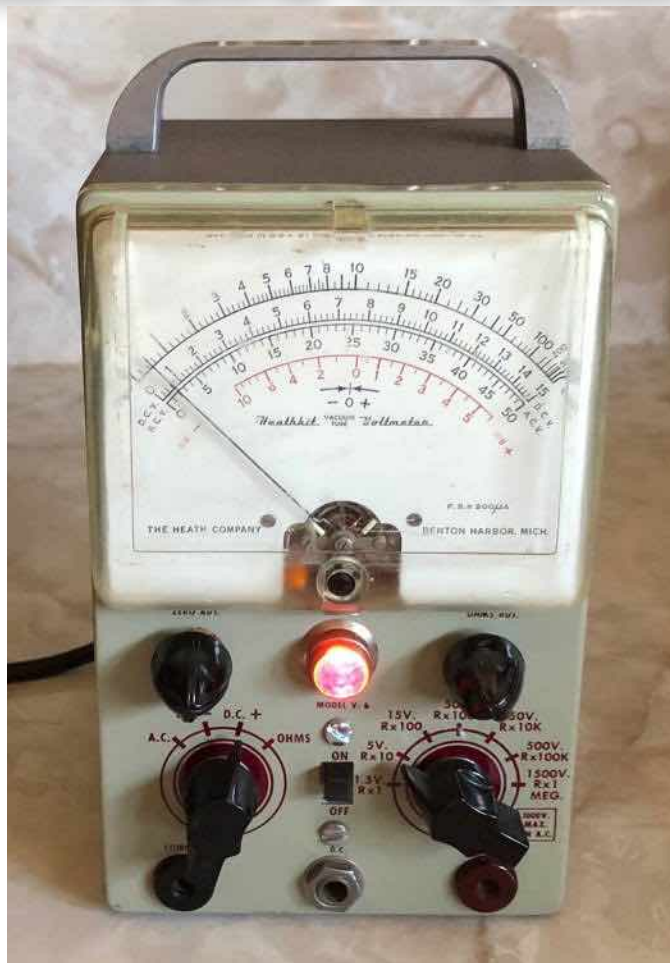
Figure 1: Completed restoration of the Heathkit V-6 VTVM during burn-in. The slight meter offset is intentional and indicates the circuit continues to function.

It seems like this project took forever to complete, though actual time working on it was not many hours over a long period. Part I appeared in the April 2018 issue of *RF* and covered “siliconizing the selenium rectifier” in the V-6. This amounts to removing the selenium plates and replacing them with a silicon diode (a 1N4004 here) while keeping the outside appearance of the original part. The restored Heathkit V-6 VTVM (circa 1952 to 1954) is shown in **Figures 1** and **2** during burn-in. **Figure 15** shows the V-6 schematic.

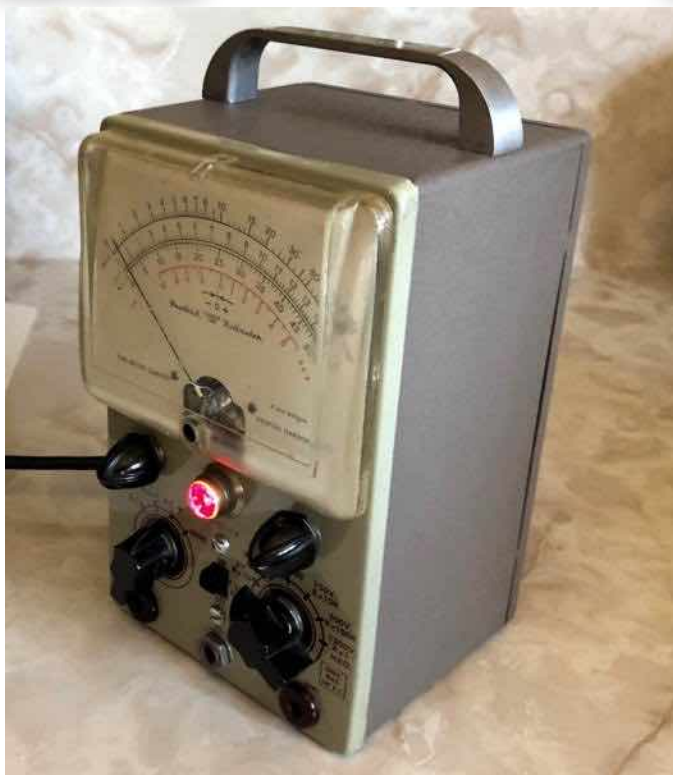
Figure 2: Another photo of the completed restoration of the Heathkit V-6 VTVM during burn-in. This photo shows the repainted case color.

The cabinet of the V-6 was generally in good shape. there were a few scratches on one side and the paint was faded and stained, even after a good cleaning. The V-6 is in the "Late Pre-Classic" style¹¹. The case is painted a gray wrinkle and seems to have a hint of brown. Finding wrinkled paint, let alone paint to match, is a problem. A base paint of the proper texture has yet to be found. I ended up choosing to leave the original paint, with its wrinkle finish in place as a base coat and cover it with a new coat of satin paint. After much searching I found Rust-oleum 2X London Gray (shouldn't that be London Grey?) paint while perhaps a little on the brown side, once on it looked close to original.

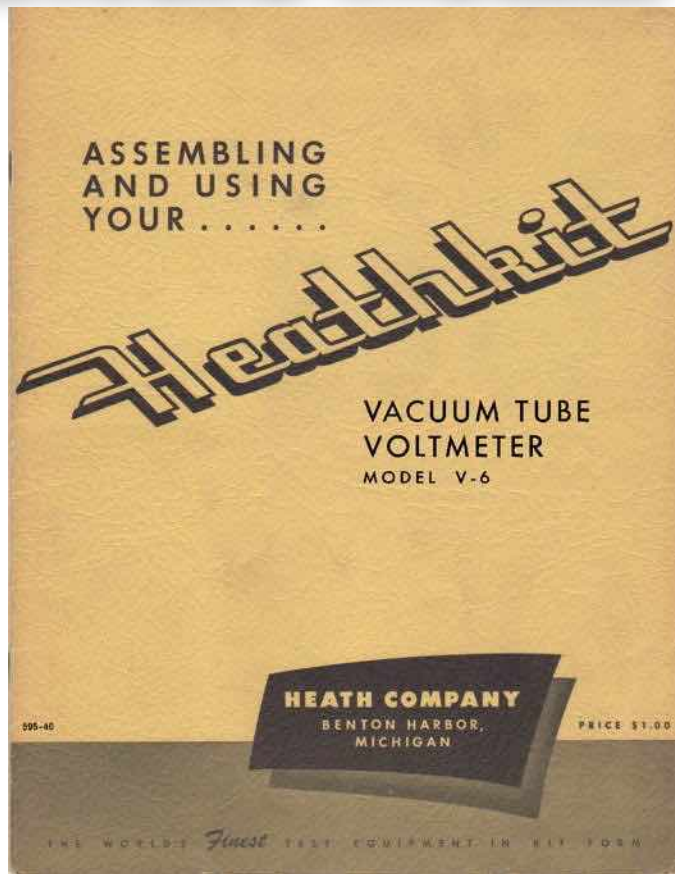
Figure 3: Having a complete manual is important.

Get a copy of the Heathkit manual for the model you’re restoring; it is a wise investment (**Figure 3**). If you are going to do anything but the most primitive restoration the manual is valuable for teardown as well as for rebuild. Sometimes manuals can be found online, however many of those online are missing the step-by-step assembly instruction section. There are many vendors that sell replacement manuals for vintage Heathkits. One source is the new Heathkit Company². Other vendor sources can also be found online. Prices and quality vary so shop around. Often original manuals can be found on eBay. It is wise to know your kit; some kits change over time. For instance there are two versions of the DX-40, each with its own

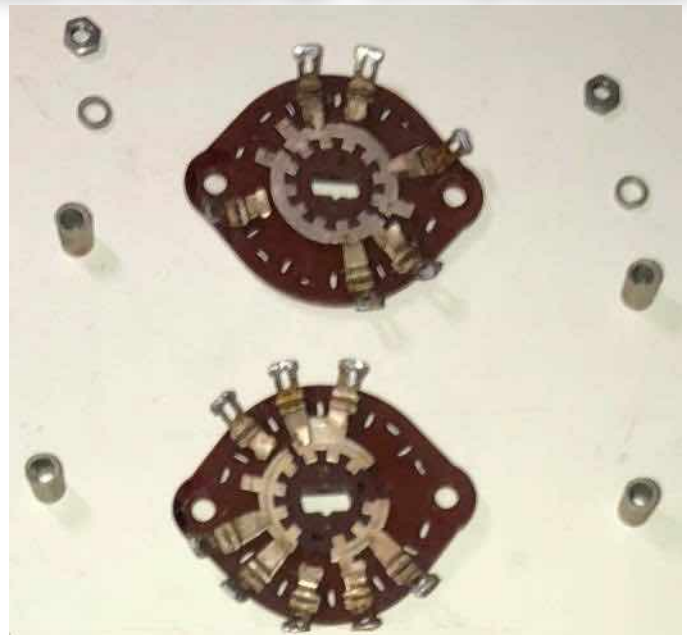
Figure 4: Disassembled function switch wafers awaiting cleaning.

The second rotary switch is the function switch. It is a four-position rotary switch with two wafers. The switch was disassembled, the mechanism cleaned and lubricated with white lithium grease. The wafers were carefully cleaned with good a contact cleaner. This is so much easier to do with the switch disassembled, and one is less likely to get cleaner on the phenolic insulation, which can compromise the insulation quality (not good in an ohmmeter that measures up to 1 giga-ohm! After cleaning, the switch was wrapped in newspaper and stored, awaiting assembly.

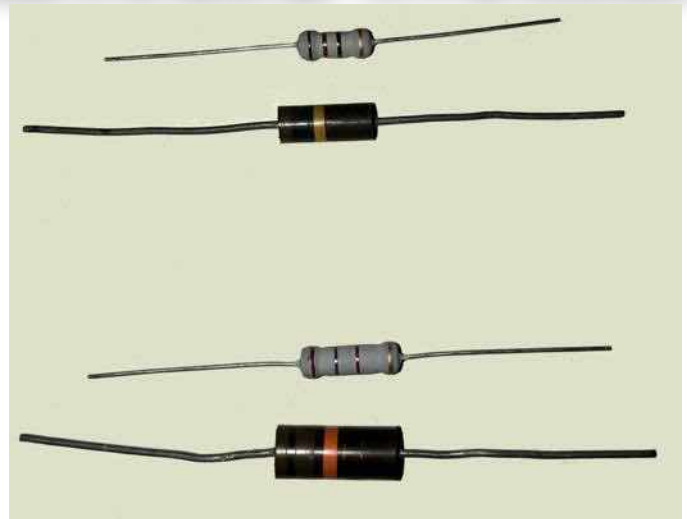
Figure 5: Resistor size comparison (from top to bottom): 1-watt metal oxide, 1-watt carbon composition, 2-watt metal oxide, 2-watt carbon composition.

1/2-watt carbon composition resistor with 1-watt metal oxide resistor and a 1-watt carbon composition resistor with 2-watt metal oxide resistor. With some exceptions, there is nothing wrong with doing this.

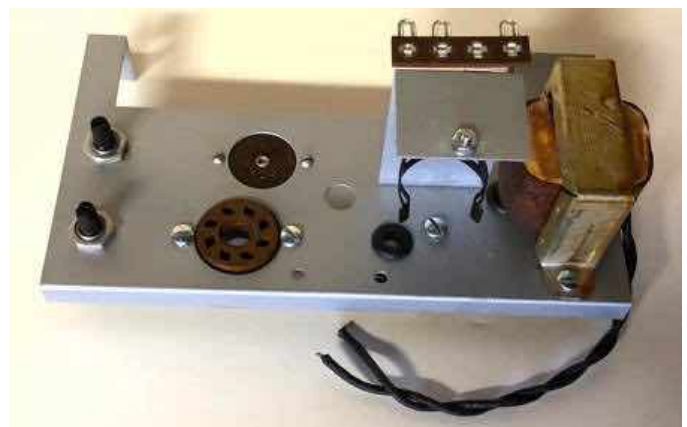
Figure 6: The V-6 chassis, cleaned, coated and partially populated with parts.

Once all components were off, the chassis and the two associated brackets were cleaned with an SOS pad and sanded to remove as much of the pitted corrosion as possible. When it was finally looking reasonably smooth it was coated with Rust-oleum Satin Nickel Metal and allowed to cure. The chassis with one of the brackets attached, along with the major components is shown in Fig-

Figure 6. Be sure all lock washers are present during reassembly and all hardware is tight to assure good grounding. No problems were encountered in area, though all grounds were checked with an ohmmeter.

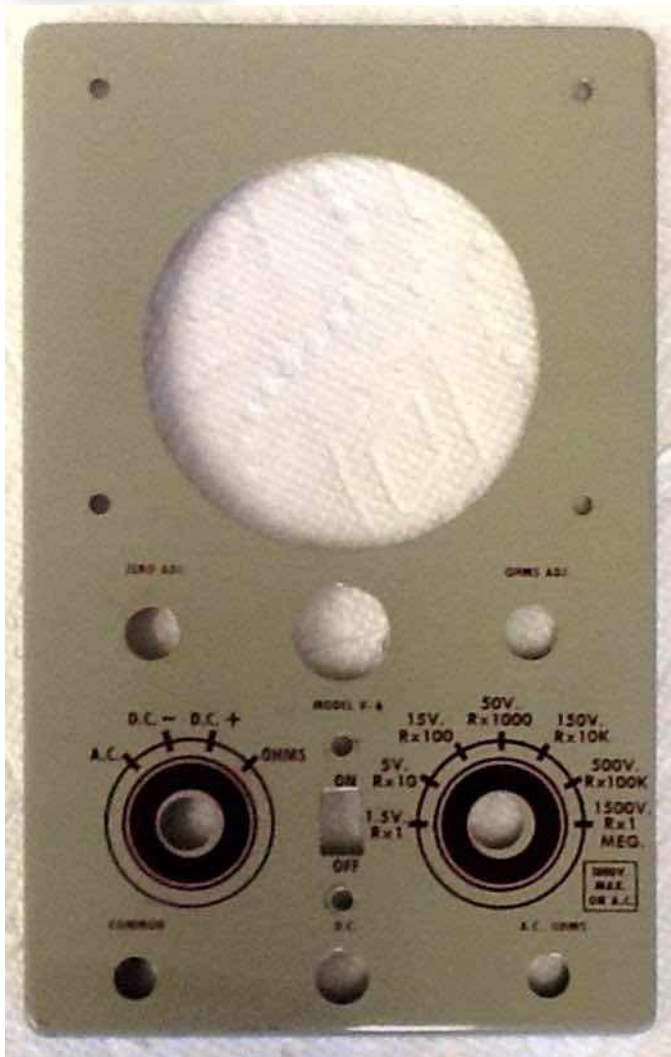
Figure 7: The front panel cleaned up nicely with just some Dawn detergent and warm water.

The front panel can be difficult to restore if scratched excessively, chipped or stained. Luckily the V-6 front panel cleaned up with just Dawn and warm water. The few minor scratches were allowed to remain “to add character”. **Figure 6** shows the front panel drying and **Figure 7** shows the back with some components installed.

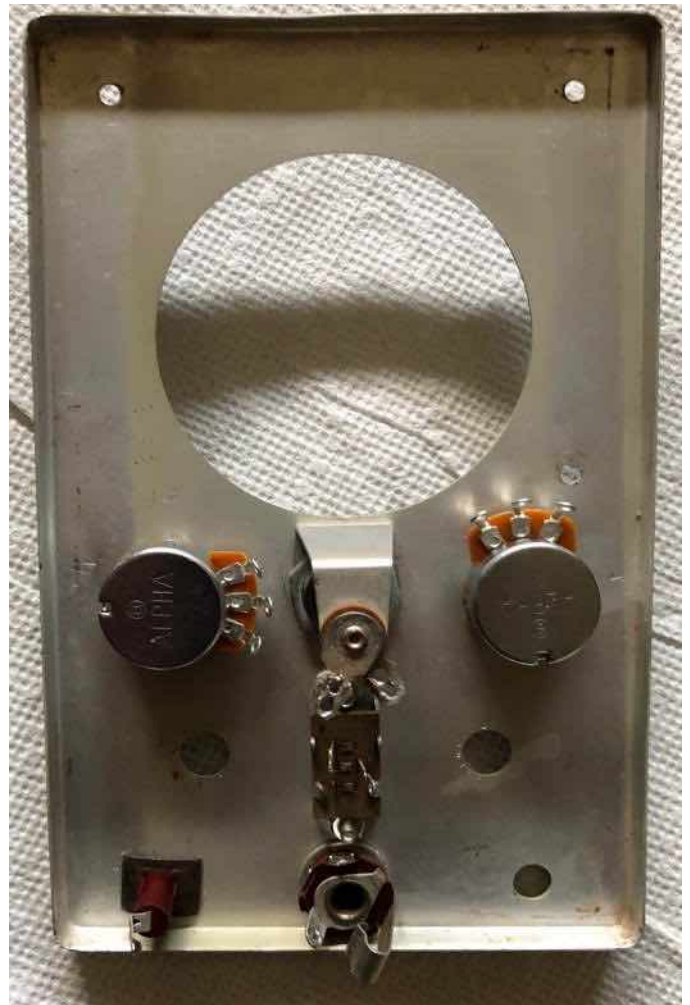
Figure 8: The front panel rear with ZERO ADJ. and OHMS ADJ. controls, pilot lamp, D.C. jack, A.C. - OHMS jack and OFF - ON switch installed.

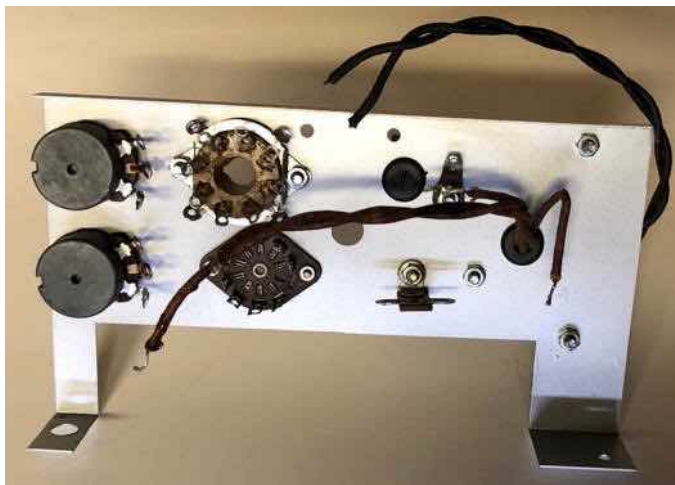
Figure 9: The underside of the chassis prior to wiring. The adjustment pots and tube sockets are original but cleaned and tested. The vacant hole is for the 7.5 MΩ pot.

Construction of the V-6 takes place in three parts. First the chassis is wired, then the front panel is wired, and finally the two are wired together. **Figure 9** shows the chassis underside prior to wiring. **Figure 10** shows the wired front panel prior to it being joined to the chassis and **Figures 11, 12 and 13** show the completed V-6 prior to being installed in the cabinet.

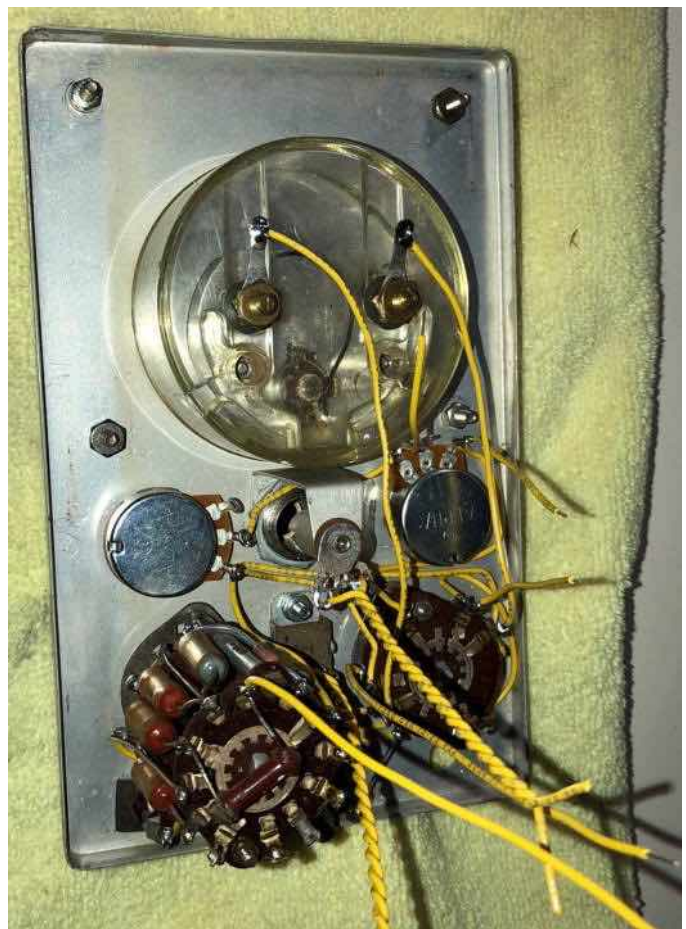
Figure 10: The underside of the chassis prior to wiring. The adjustment pots and tube sockets are original but cleaned and tested. The vacant hole is for the 7.5 MΩ pot.

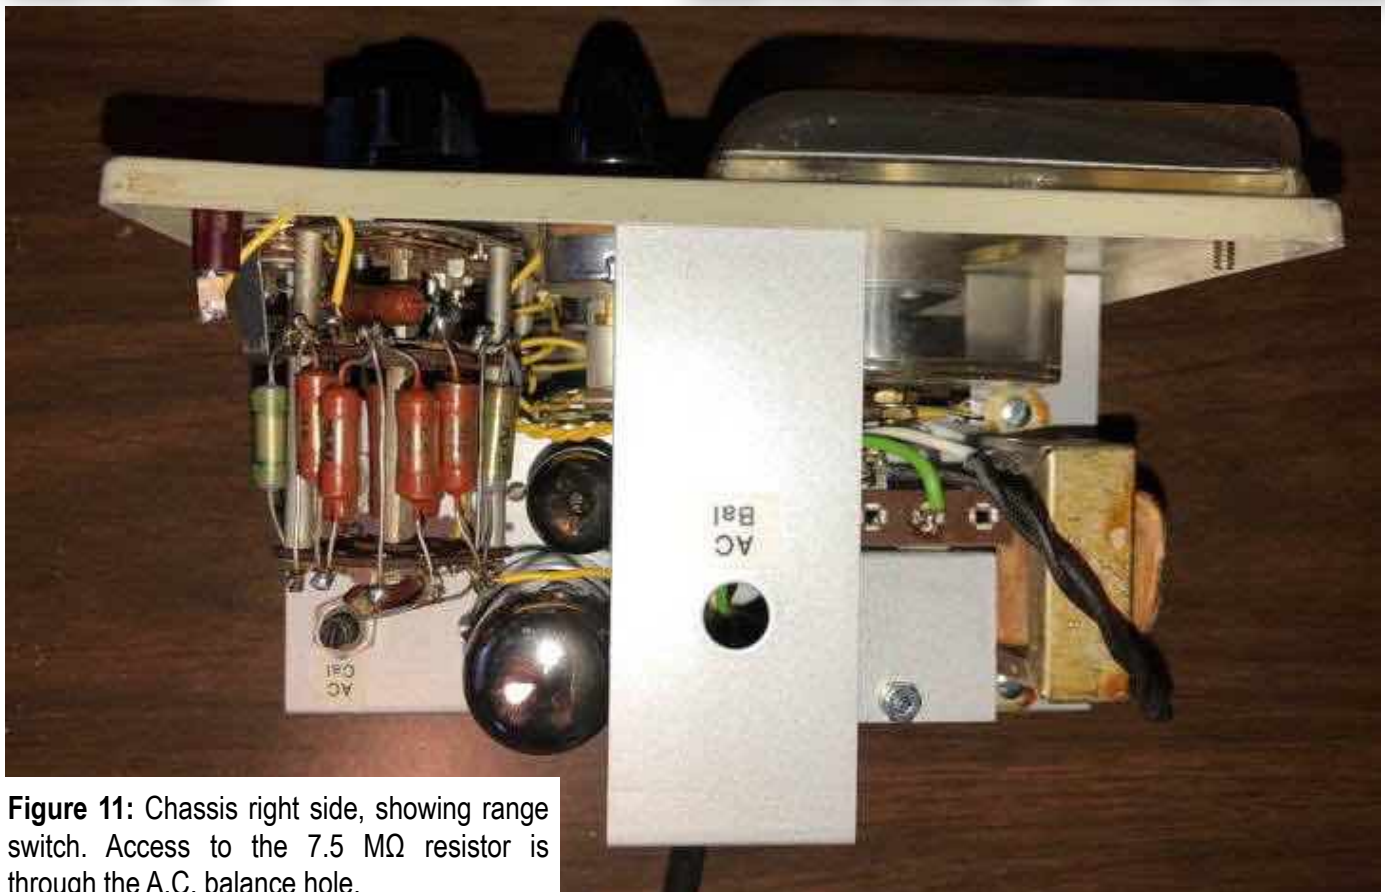
Figure 11: Chassis right side, showing range switch. Access to the 7.5 MΩ resistor is through the A.C. balance hole.

enough apart so large precision resistors can be mounted from one deck to the other. In total, the switch holds fourteen precision resistors. Since they are easy to damage and hard to replace, there was no reason to remove them. The switch itself was cleaned and all resistors checked. One 200 K Ω precision resistor was obviously open as it was bypassed by two tiny 0.1 watt 100K precision resistors in series. These were removed, as was the dead original, and a 200K precision resistor was ordered from a parts warehouse (luckily it was a common value, unlike some of the others). The range switch had suffered some of the corrosion damage caused by the leaking battery. It manifested itself on the nut end of one of the long screws holding the wafers. The nut and an area of the screw around the nut were rusted. Instead of trying to unscrew it a rust converter⁵ was used to neutralize the rust and prevent further damage.

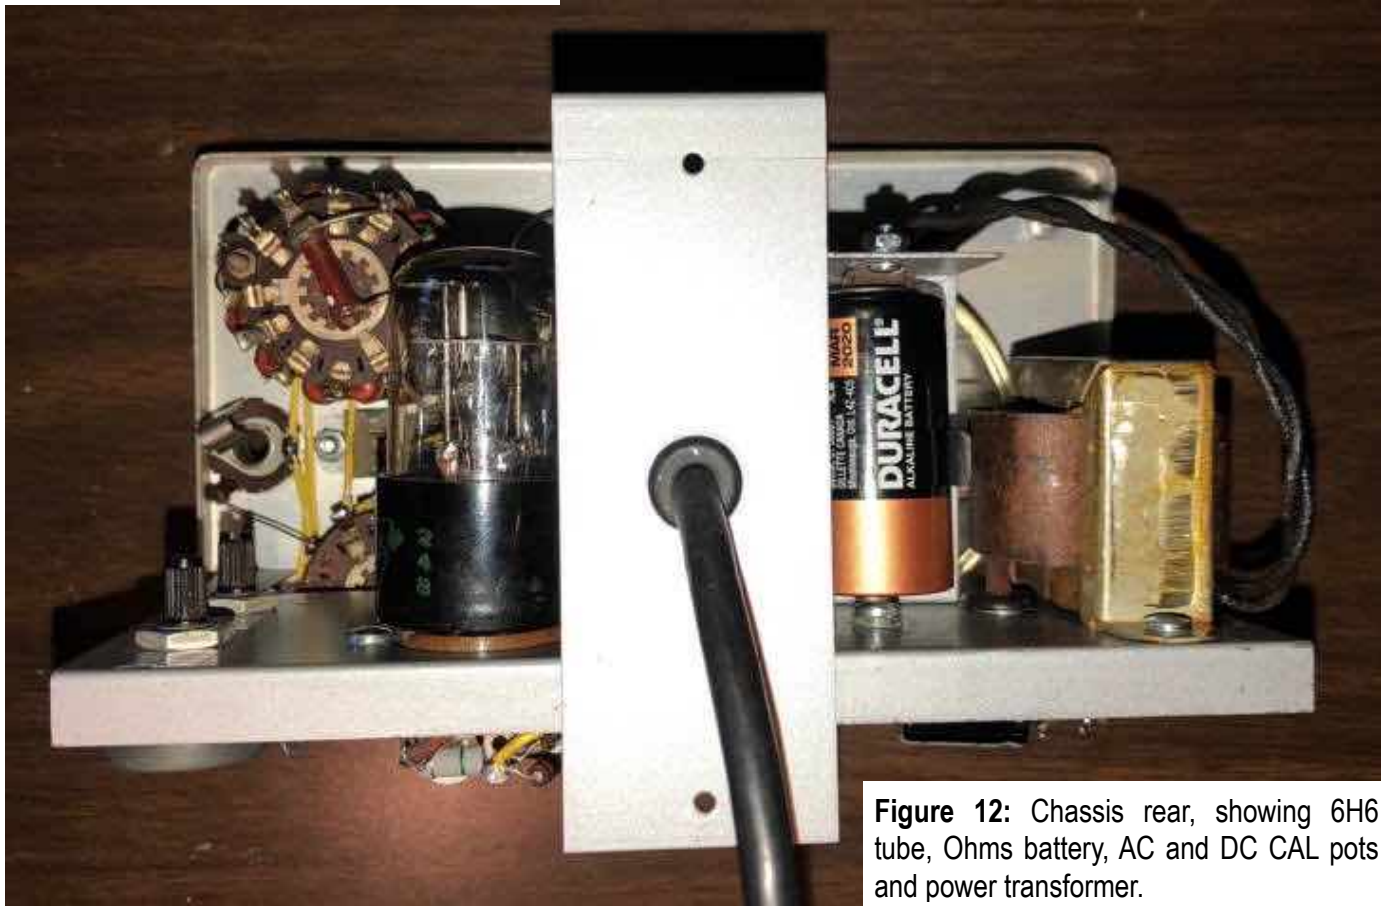
Figure 12: Chassis rear, showing 6H6 tube, Ohms battery, AC and DC CAL pots and power transformer.

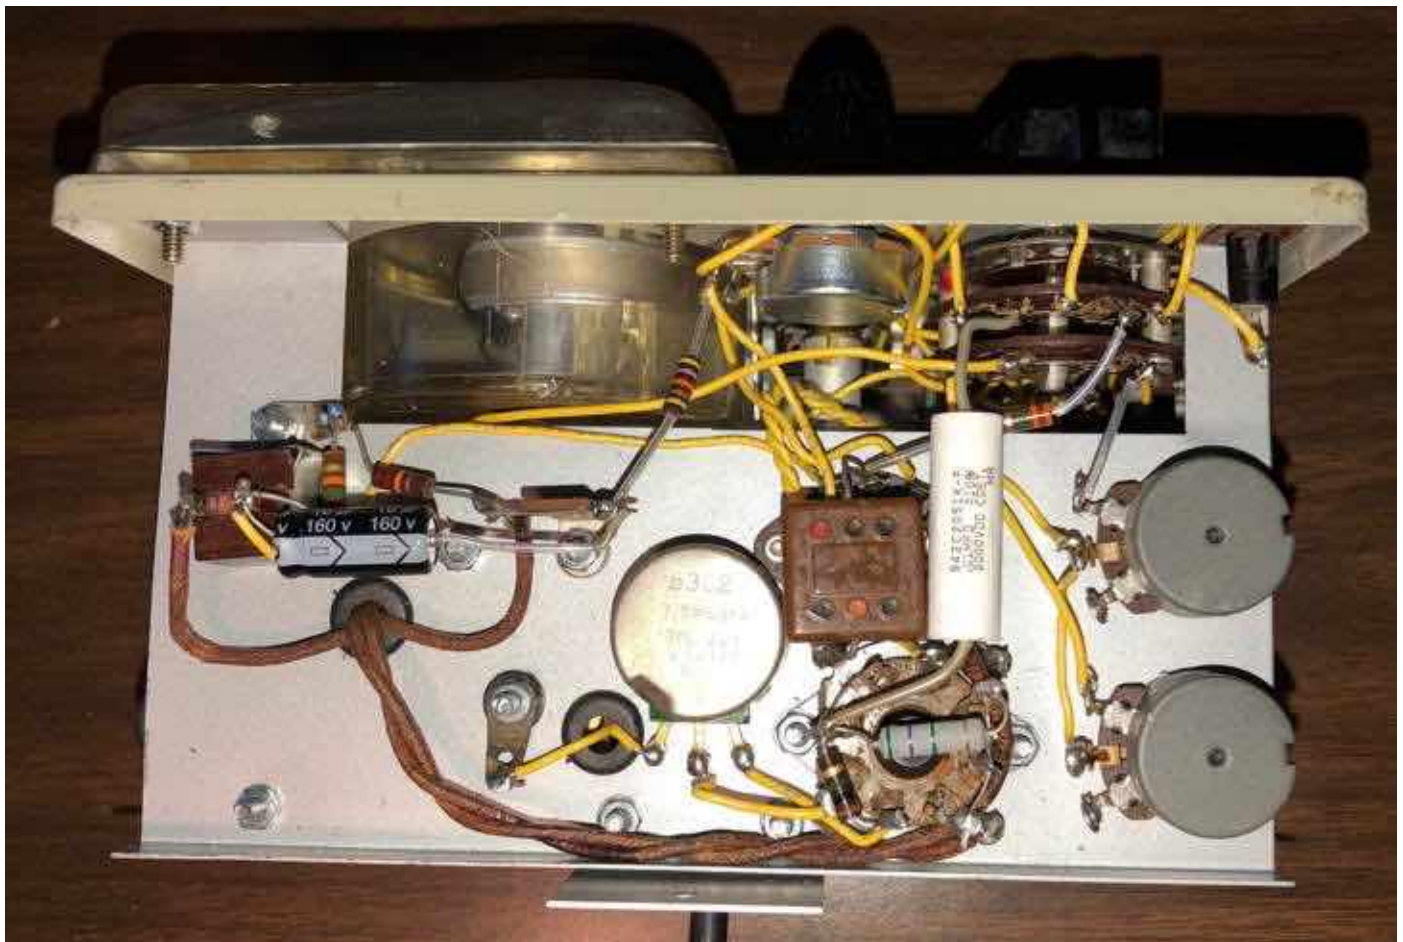
Figure 13: Chassis left side, showing "siliconized" selenium rectifier (left), 7.5 M Ω potentiometer (lower center), old style mica capacitor and new 0.01 2,000V capacitor (above octal tube socket), and function switch (in cutout, to right).

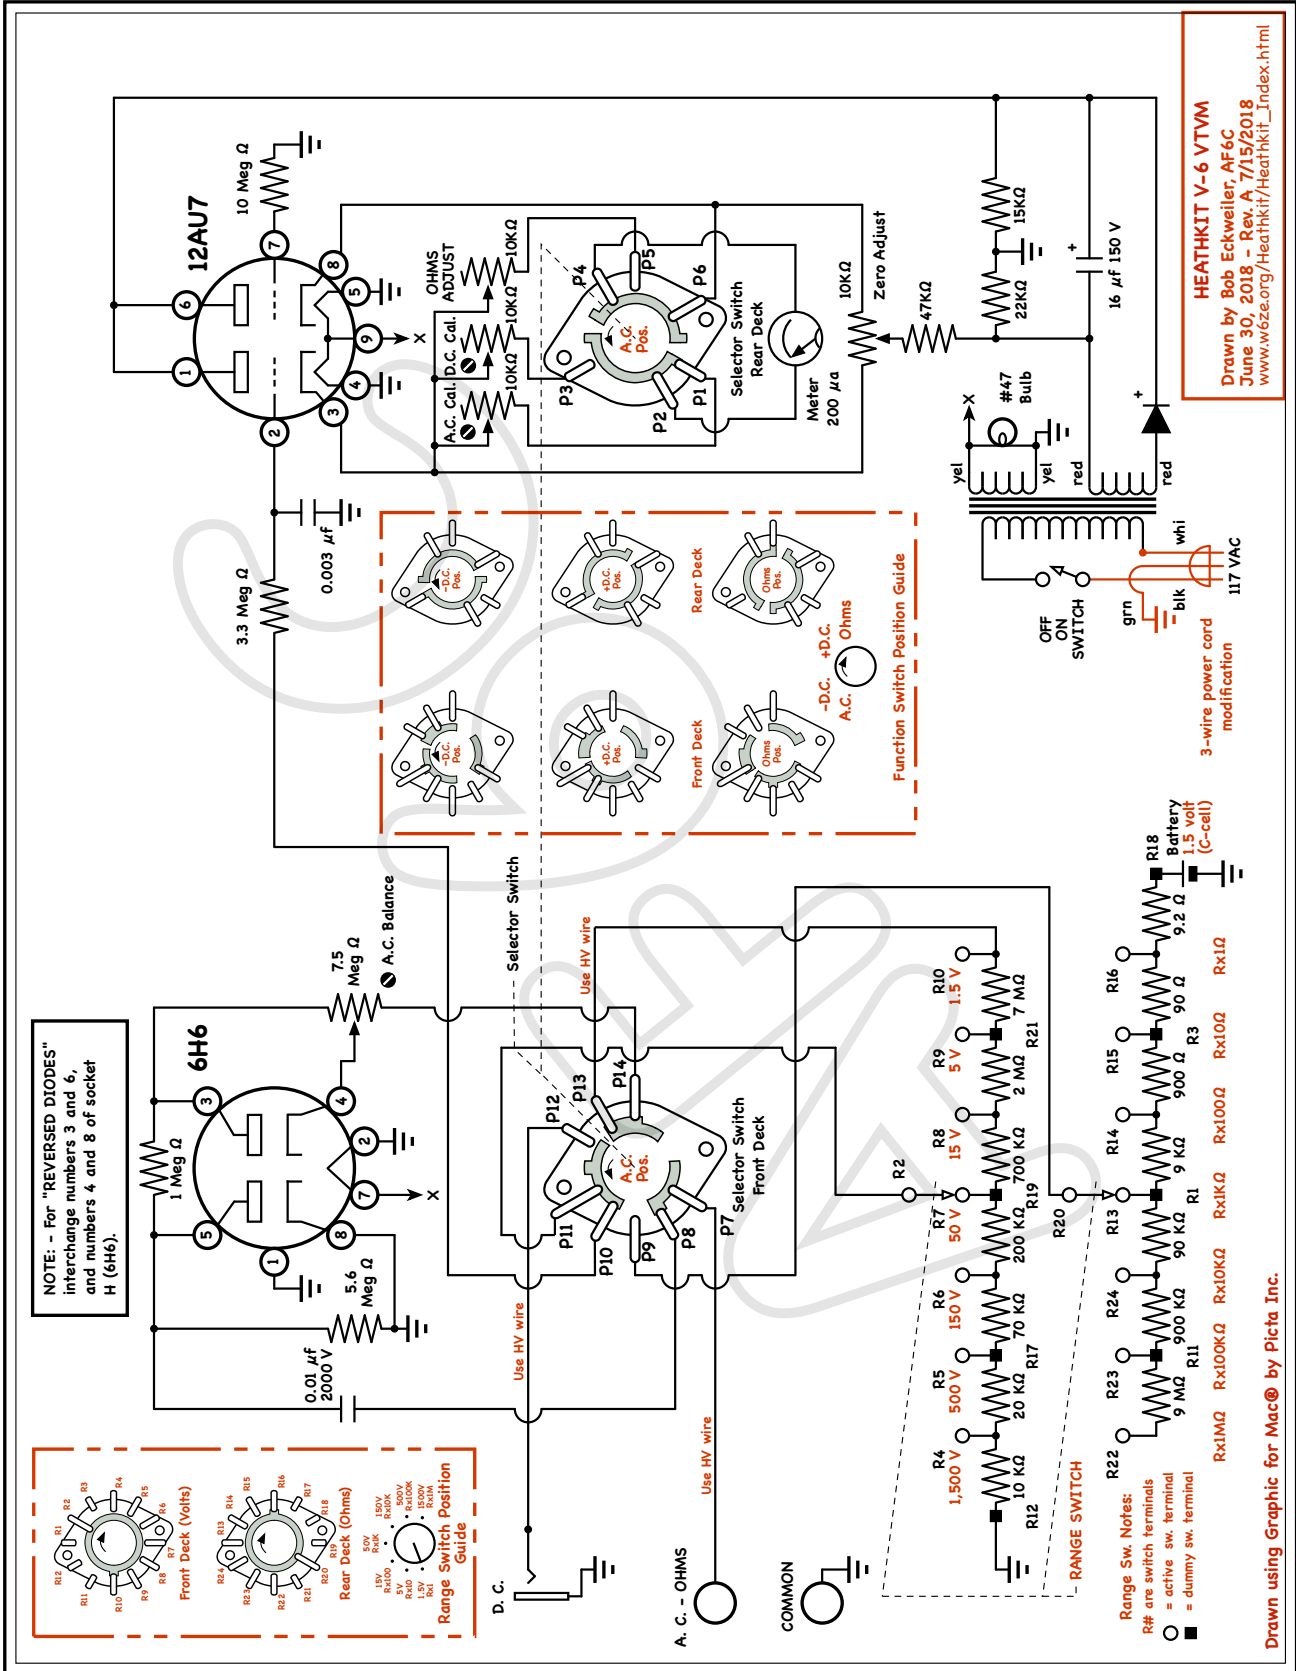
HEATHKIT V-6 VTVM
 Drawn by Bob Eckweiler, AF6C
 June 30, 2018 - Rev. A 7/15/2018
www.w6ze.org/Heathkit/Heathkit_Index.html

Figure 15: V-6 Schematic. A high resolution copy is at: www.w6ze.org/Heathkit/Sch/V-6-Sch.pdf
