## Restoring an Icom 290A

Tony Jones G7ETW gets a real 'oldie' working again.

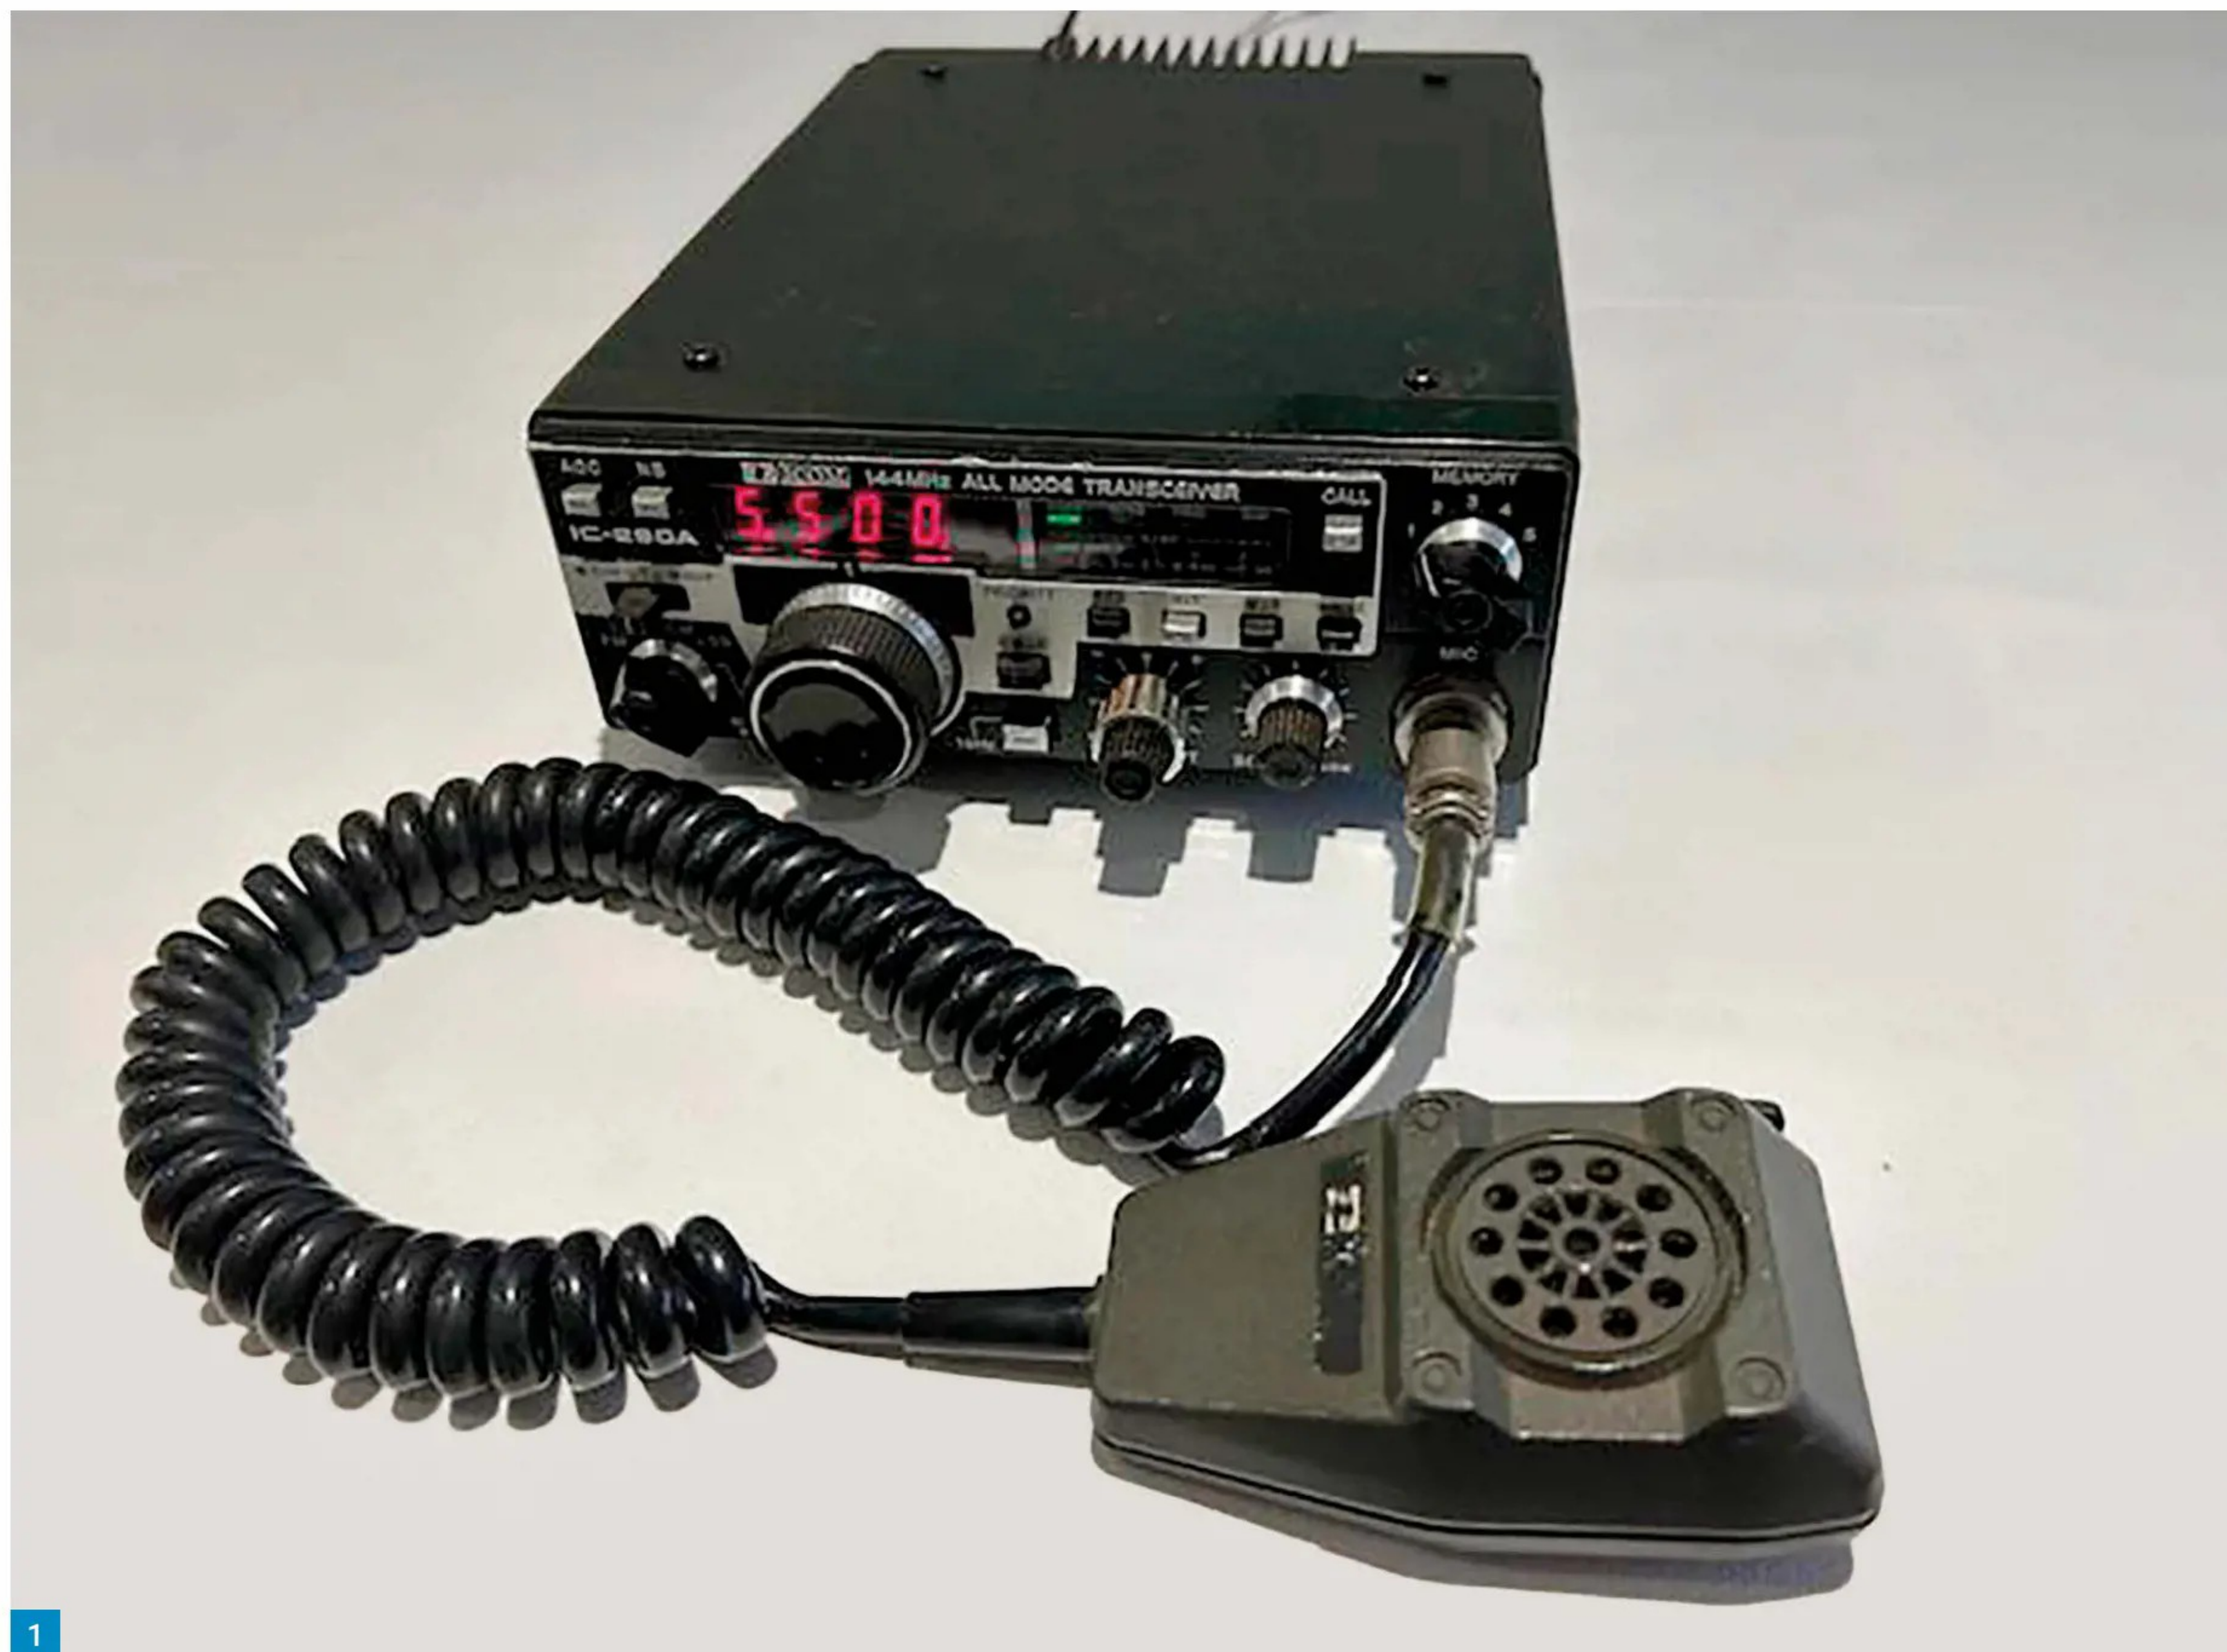
1

As anyone who knows me knows, I am a sucker for a radio of character that needs a bit – but only a bit – of work. **Photo 1** shows an Icom IC290A, a 2m multimode from before I was licensed. It came to the Radio Society of Harrow as part of a large silent key sale. After clean-up – it spent many years in a garden shed – and testing, it was found to be working, but not fully.

Photo 1: An Icom IC290A.

This radio now works – very well actually. The buttons operate, all of them, and the volume control isn't even scratchy (it must have been a dry shed!). Power out is 12W (high) and 4W (low) on FM and SSB. The original specifications quote 10W and 1W, so this may have been tweaked at some point. My repaired microphone works perfectly and I've been getting compliments on my transmitted audio.

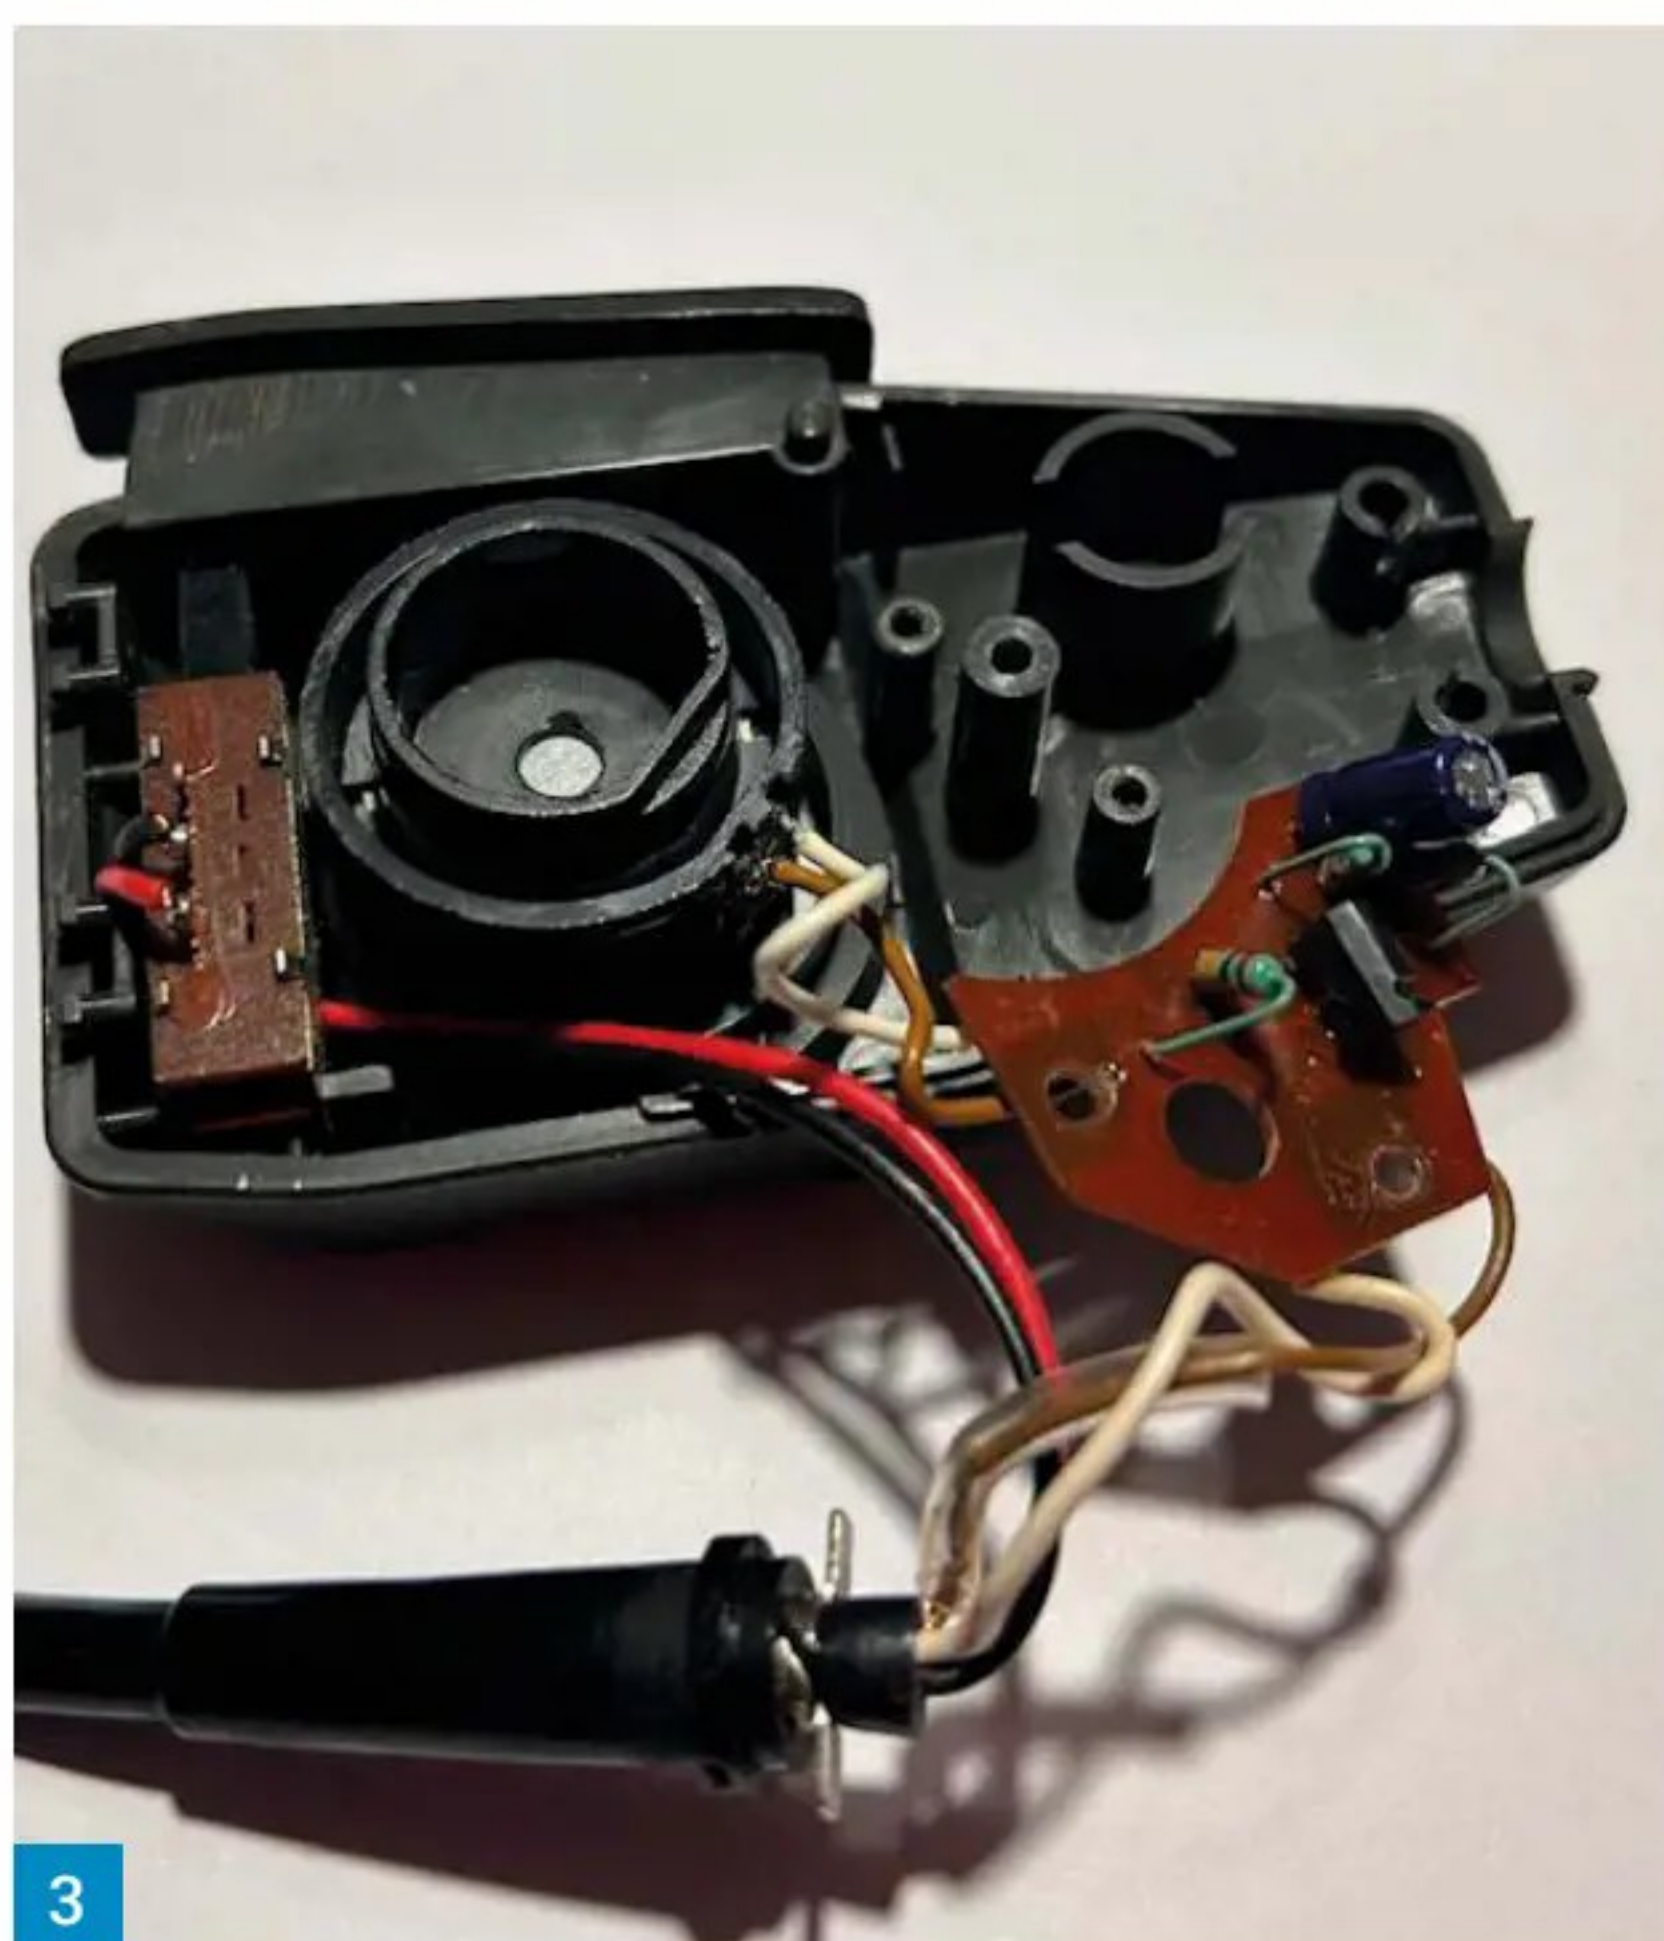
3

The fault really had to lie in the HM7 strangely futuristic-looking microphone. **Photo 2** shows the circuit diagram and **Photo 3** shows the internals. This microphone has a dynamic moving-coil insert with a one transistor amplifier. I had never heard of a 2SD661 but the application is simple enough and I thought almost any NPN would do if the original had failed.

circuit. I removed it and checked – yes, it had!

Photo 3: Microphone internals.

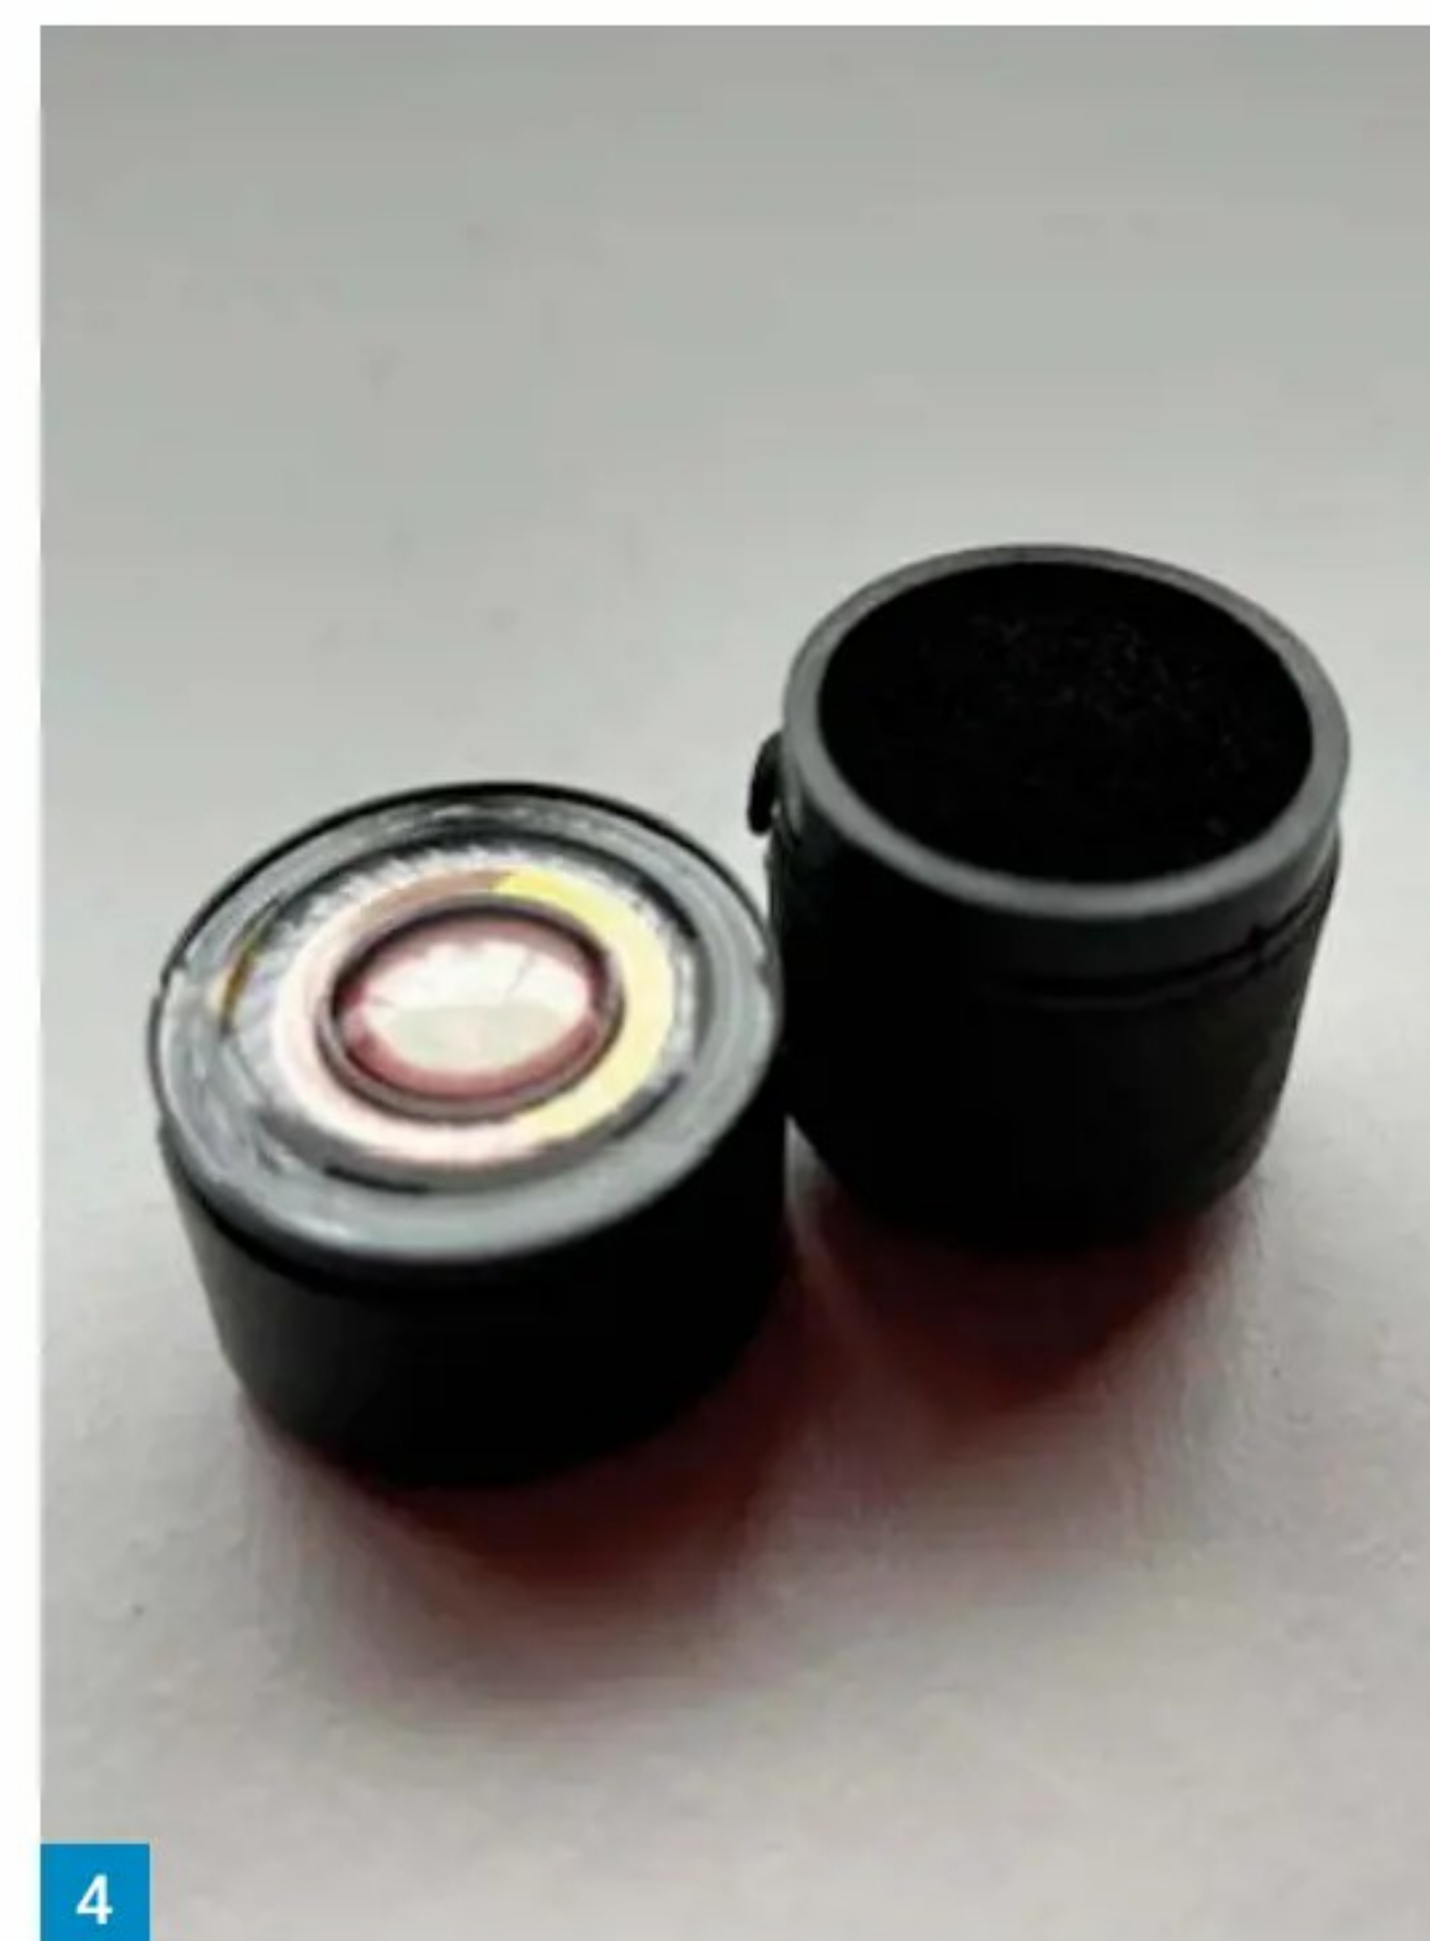
4

New dynamic capsules are available, and not expensive. But as **Photo 4** shows, there was a problem. The original, left in the photo, is 25mm in diameter and 25mm deep. The new one is the same width but 9mm deeper. By removing an internal fixing into which the back-of-

Photo 4: Microphone capsules.

microphone hanger was secured, I found there was just room without resorting to amateur surgery.
