# Hammarlund Pro-310

## Service Notes

Grant Youngman, NQ5T

## The Hammarlund **PRO-310** Project

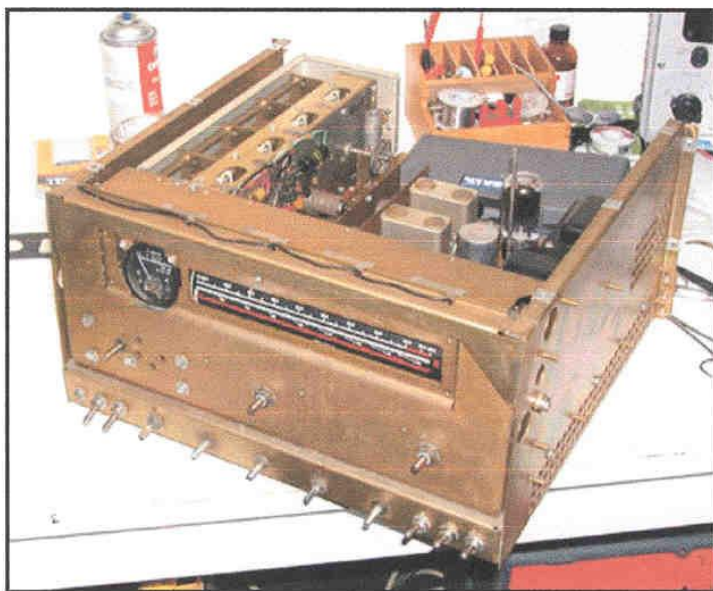
Outside of the skins, this is what the PRO-310 looks like:

The side panels are welded to a solid L-bracket that goes across the front top of the receiver, and also are welded to the bottom assembly where the various controls are attached.

The center section of the front panel is where much of the tuning mechanism mounts, and it is solidly attached to the tuning capacitor and turret assembly that occupies the entire left side of the radio.

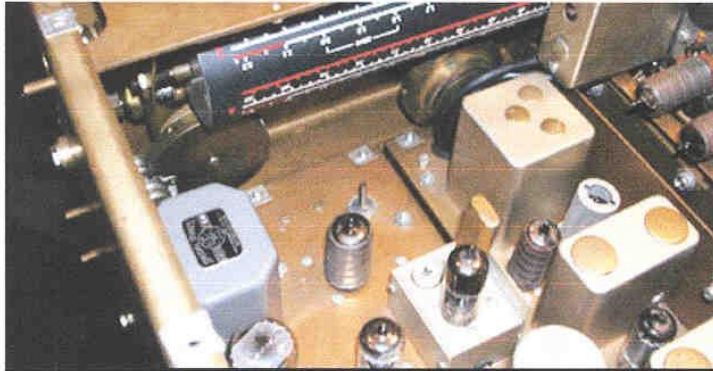
It is also possible to see a little of the tuning mechanism, dial drum,

The two flywheels (one behind the audio output transformer on the left, and one behind the IF can on the right), are for the main and handsread

the main and bandspread tuning. The fingers just don't fit in there. These have integral pulleys that drive the dial cords for tuning.

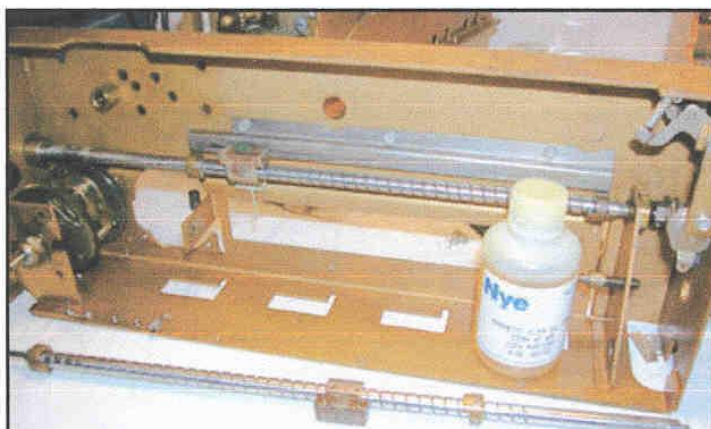
The final issue at this stage was attacking the follower on the main tuning screw which, you may recall, was more or less welded in place. I removed the main tuning screw and soaked it for a day in penetrant. Finally after several tries it came free.

I still don't know for certain whether it was a small amount of rust buildup or just old grease that had turned to a solid epoxy-like mass. There are some small marks left behind on the screw, which should polish out with a little jeweler's rouge.

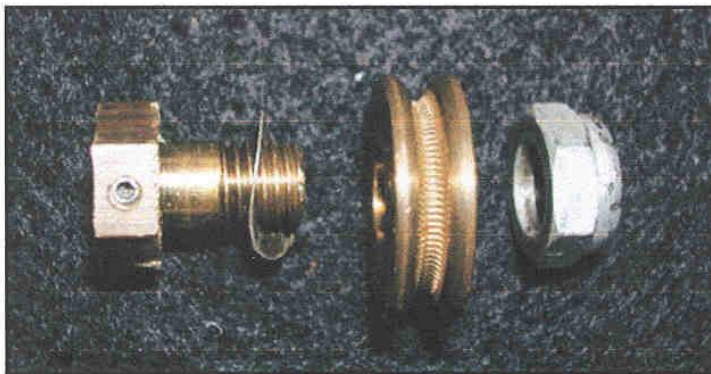
The pulley assembly itself consists of several pieces:

The pulley is held on the fitting between a spring washer and nut. I believe the point of this is that the nut should be tightened just enough for the pulley to rotate the tuning shaft in normal travel without slipping. When the pointer follower hits the end stops, I suspect the pulley is supposed to

The upside is that this will allow the knob/pulleys/cord to continue to rotate without the risk of wear damage to the braided tuning cords. This could result if the pulley on the screw actually locked in position at the end of pointer travel and the operator

kept cranking away on the knob. The downside is that if the lock nut is not quite tight enough this becomes another potential source of slippage in the tuning mechanism, aggravated by old thickened grease and high friction in the mechanism.

Some good news, though ... It is possible to adjust the pressure of the pulley against the spring washer without complete disassembly of the radio. It is necessary, however, to partially remove the cabinet to access the lead screw end through openings in the front sub-panel assembly. I suppose in the extreme one could just snug it up tight and take some care when the pointer reaches the end of travel. The fact that this is one of the few mechanism adjustments that can be made post assembly leads me to think that Hammarlund expected this might need tweaking from time to time to keep the radio operating properly.

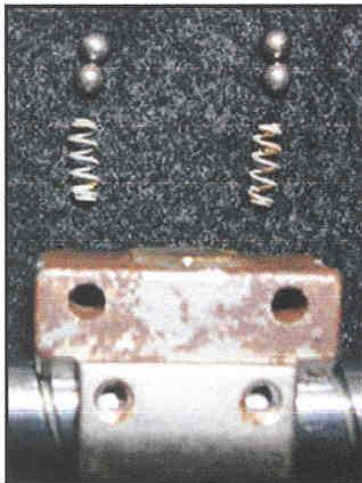
The pointer followers are driven by the lead screws and ride a metal track to hold them in the correct position relative to the tuning scale.

The followers are held against the metal track with a pair of small springs and ball bearings. The pointer itself has an extended metal plate on the rear which holds these bearings in place and finishes the "clip" that fits over the track. One of the ball bearings got away from me during disassembly, and after several hours crawling around the room with a flashlight and magnet hunting for it, I gave up and bought all new 1/8" chromium steel balls from McMaster-Carr.

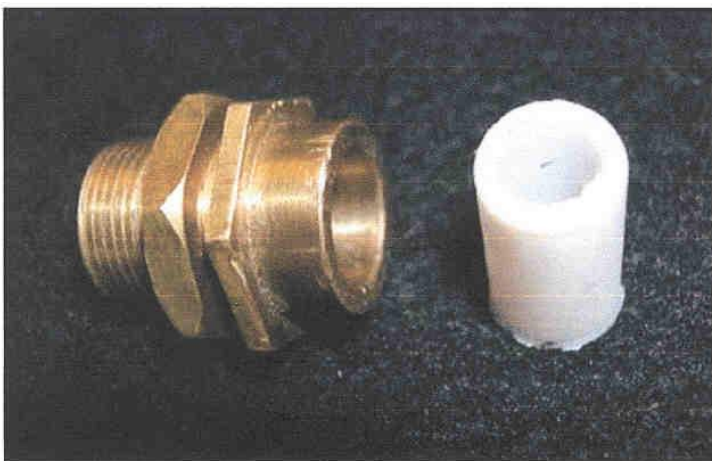
I had to damage the insert to get it out, but it is nothing more than  $3/8$ " O.D. and  $1/4$ " I.D. standard white Teflon tubing.

I cut a new insert, and with a little more careful measurement found the brass bushing to have an inside diameter of  $23/64$ " rather than precisely  $3/8$ ". I was able to insert the Teflon,

but still had to drill it back out to 1/4" since the I.D. of the Teflon reduced when the 3/8" Teflon sleeve was compressed into the 23/64" housing.

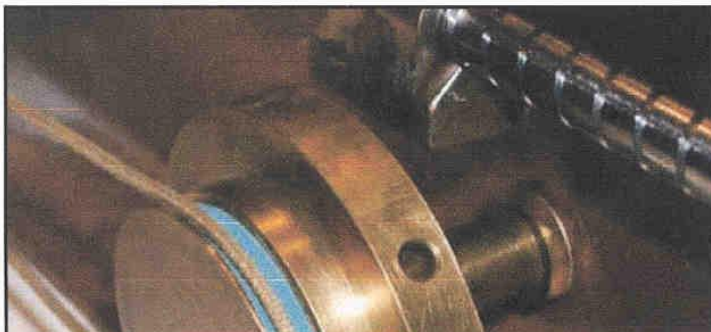
To check this out temporarily I used an ordinary household rubber band stretched around the pulley and reinstalled the essential tuning mechanism pieces for testing.

The experiment worked perfectly, with absolutely zero slip between the drive pulley and the tuning cord. If it wasn't for the fact that I'd be afraid the rubber band would quickly disintegrate, I'd just leave it there.

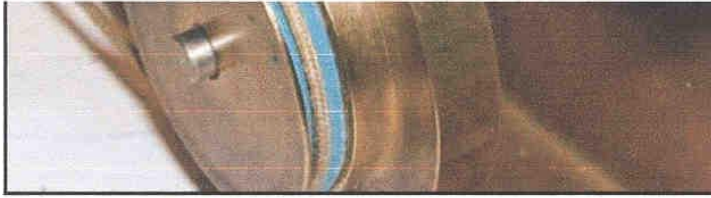
I then tried flat urethane I'd previously purchased from McMaster, but the hardness of the material is too high, and it does not provide as much

friction as the simple rubber band. I also had some difficulty welding the ends of the small urethane straps into a stretch band ... and am not inclined to spend \$350 for a splicing kit. So I need to find another suitable material.

I was able to set the tension of the small lead screw pulley against its spring washer (see previous page) to provide non-slip drive action until the pointer follower hits the stop. After the follower hits the stop, the small pulley does spin against the spring washer to prevent friction damage to the tuning cord. It takes some fiddling to get the tension right, but it works.

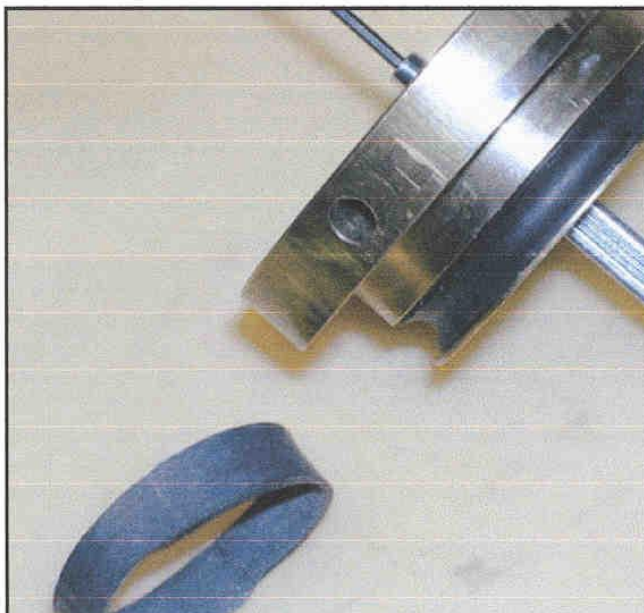
The result looks like this:

The measured temperature (thanks to John, K7RLD) in the sub-front panel area is about 100 deg. F. The butyl rubber in the tire tube material should easily be able to handle that.
