# Badrestorer's Illustrated Guide to Restoring the Zenith Trans-Oceanic H500

Written and Photographed by  
John Kopp

Edited by  
Ed Morris

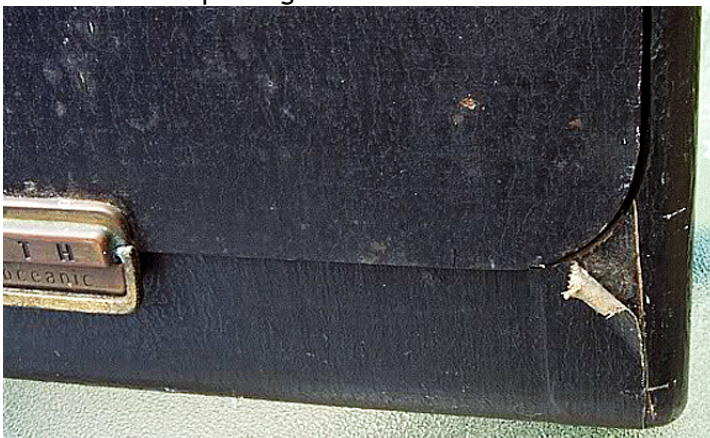
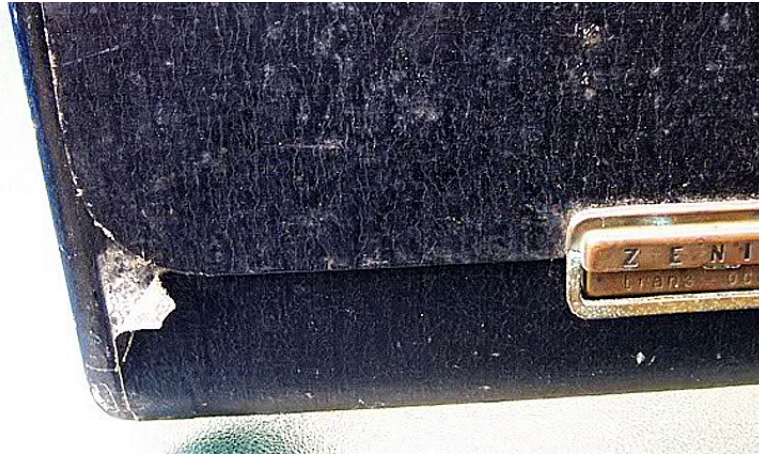
There's a little peeling at the bottom of both front corners, but no big deal:

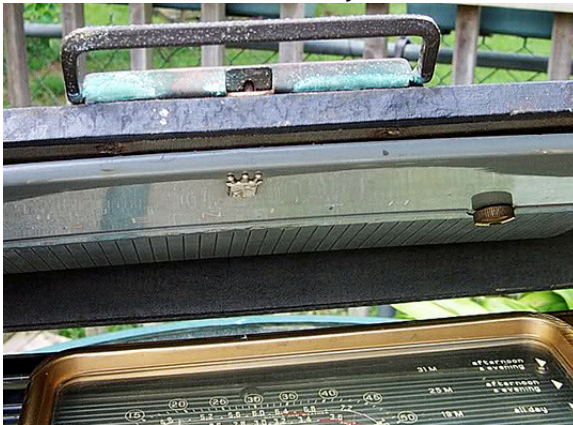
The brass front latch is very corroded. I'll have to get on that puppy right away:

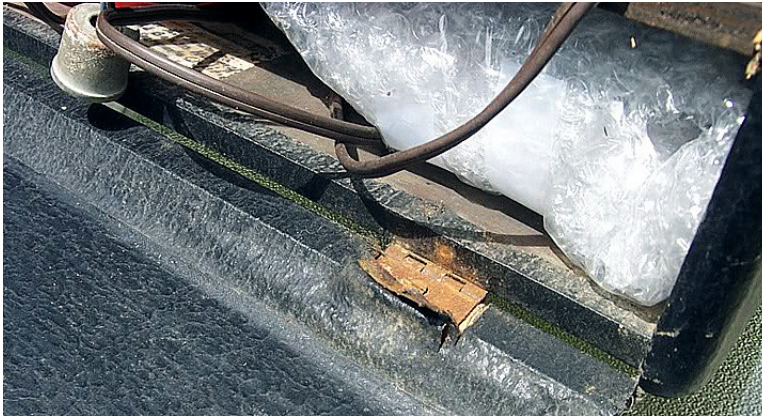
Inside of the back cover there's more peeling and both hinges are very rusty. Easy to deal with:

Coarse sandpaper and three applications of Naval Jelly took care of nearly all the hinge rust. Later on both will get one more Jelly treatment:

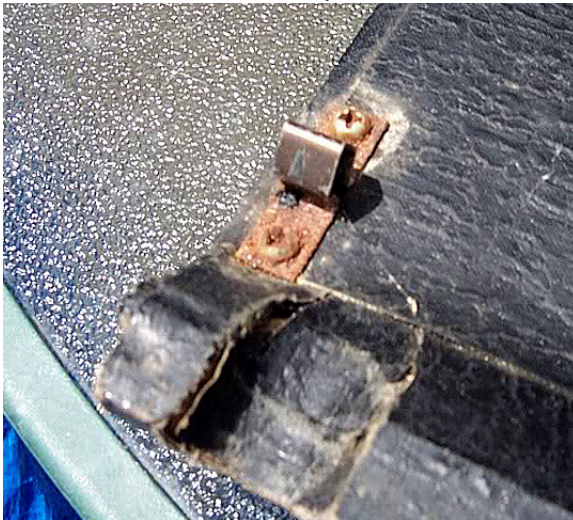
The left rear cover latch is ok, but the screws holding the right one have been pulled out of the wood. Another snap to fix:

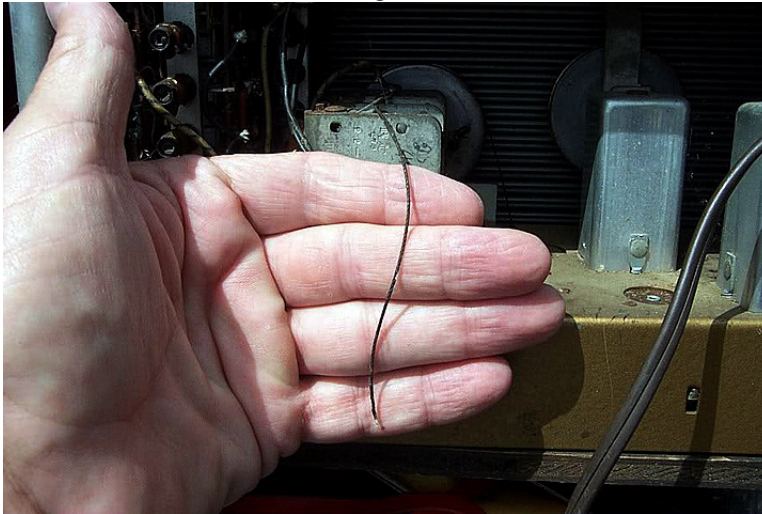
The chassis has two dial strings. One is broken:

Let's take a look at our dial string problem. Translation: The gray plastic dial scale has to come off.

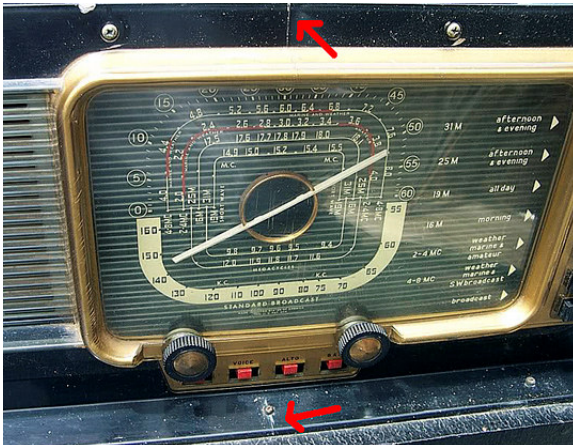
The plastic faceplate is cracked at the top and bottom. I understand it's fairly common with this model:

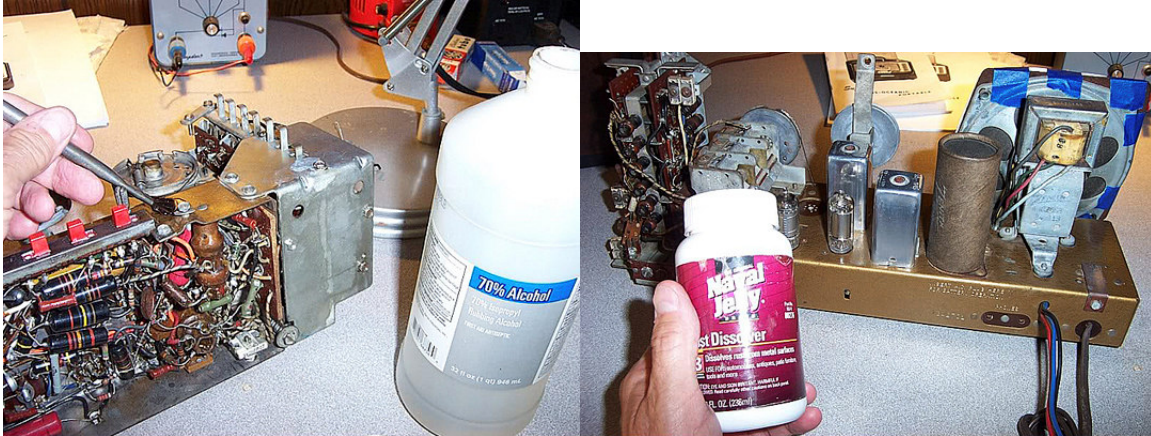
This chassis is in excellent shape...having only light dust and a couple of very small rust spots. I'm really thankful for that. Some alcohol, a couple drops of Navel Jelly here and there (and a little Brasso) took care of everything:

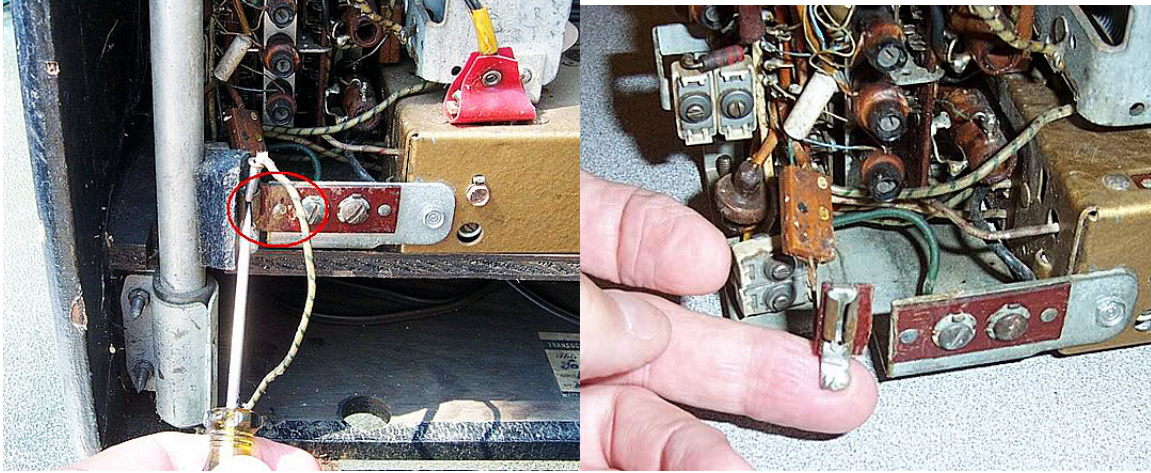
Remember that circled brown stuff? It's a lot like soft Liquid Nail. Somewhere along the line the phenolic antenna connection strip got broken and a tacky repair job was done. Get it?...tacky? I kill me. Moving right along...the glue and a mica capacitor lead were barely holding the broken section in place. It needed to be made righteous. I used a small screwdriver blade to scraped away the glue, then separated the two sections.

The edges were cleaned and a bead of J-B Weld applied to each, but they weren't fitted together right away. I instead waited until things got very, very gummy, almost semi-hard, then pressed them together. Worked like a charm...no clamping or taping needed.

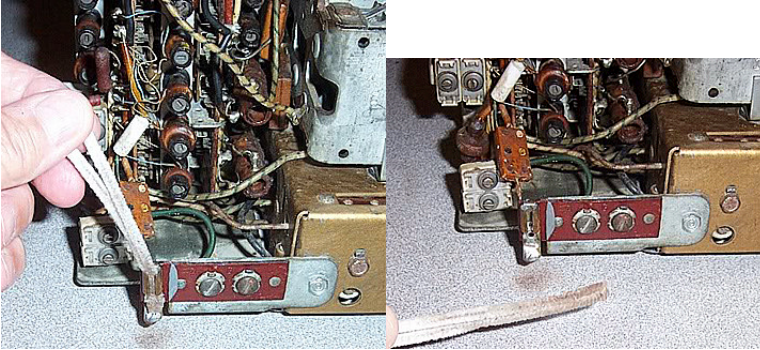
A pipe cleaner and alcohol scrubbed the inside of the shortwave antenna connector clip. It was dirtier than expected:

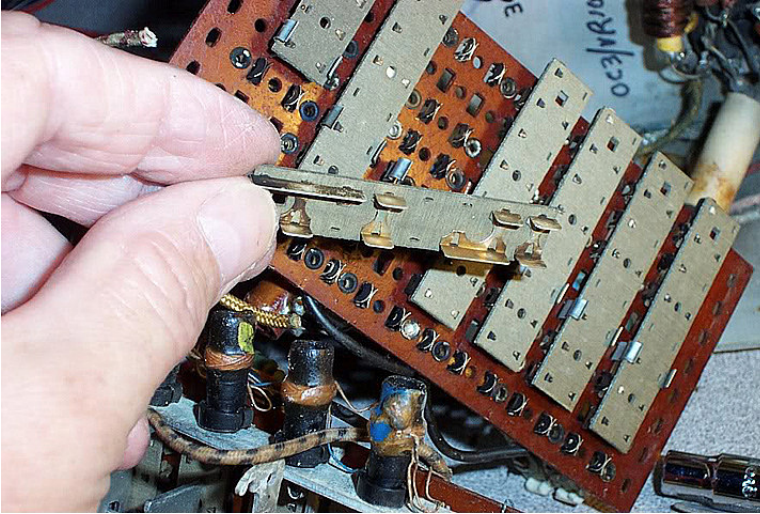
This shows the backside of the circuit board. Notice that the brass slide-switches aren't overly exposed. I've been hesitant about squirting even a little WD-40 down into the switching mechanism for fear it would drip on the slide-switches and cause arcing. I can now rest a little easier:

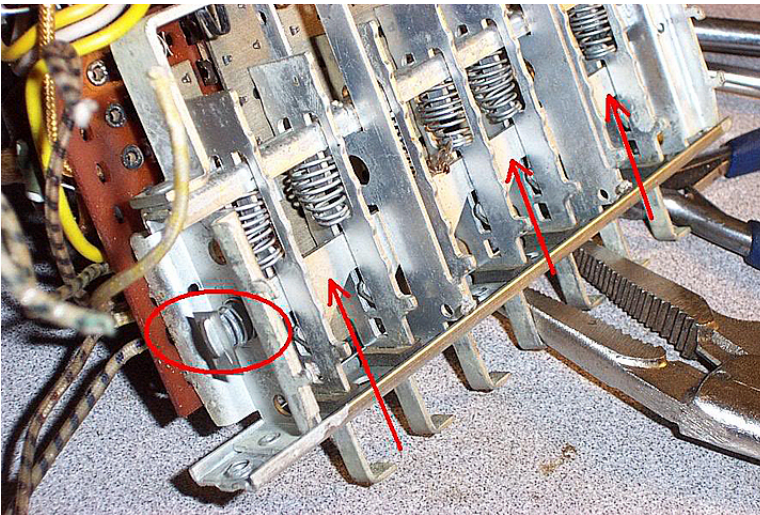
This is the pain-in-the-butt shaft that's been jamming. But I just might have found the solution.

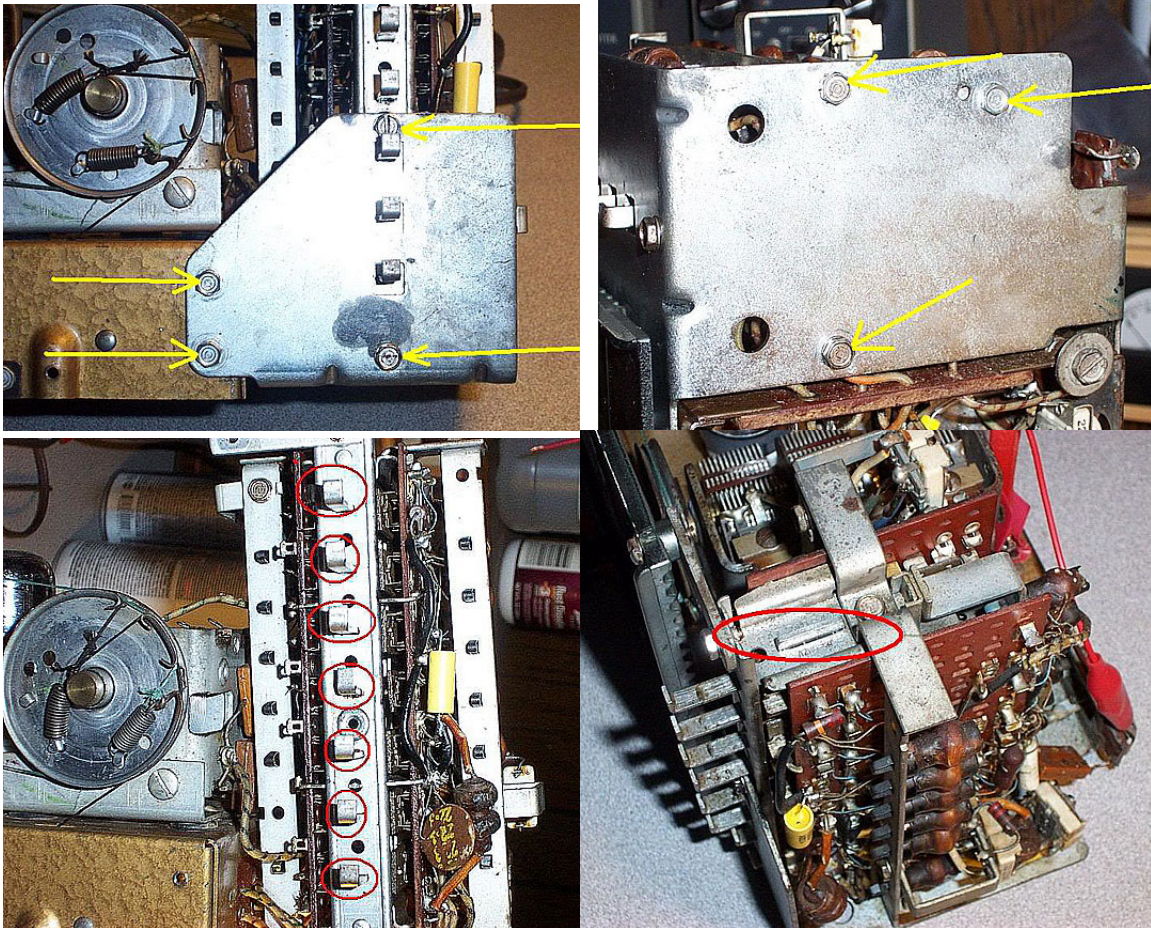
It turned out that the little bar was actually the top of a flat shaft that ran clear to the bottom of the tower. Along it were cams that were supposed to drop through a hole and hold the switches in place after they were pushed in. Apparently, something was not providing enough downward pull on the bar, preventing the cams from firmly engaging the holes. Was there a broken spring beneath the tower?:

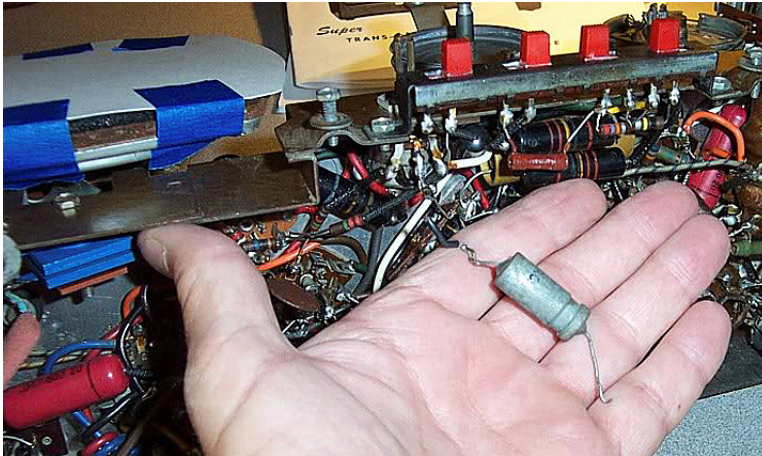
Now for a peek under the hood. Other than a hanging audio coupling cap connected to the volume control center tap, all else looked great. I have no idea if the cap is original. Off hand I'd say no, but it makes no difference, as it'll be replaced. I temporarily removed it:

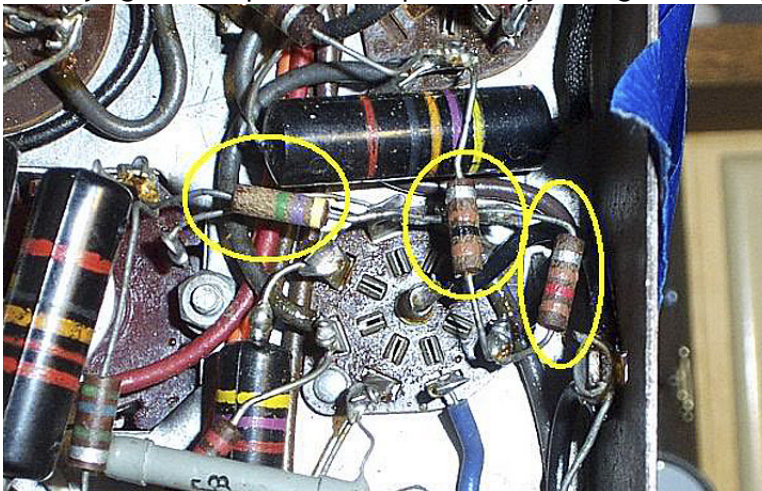
The circled resistors (in the photo below) look like dry drift wood. I don't trust them, so they'll soon be leaving this chassis. I recommend that you always eliminate resistors that look this way, even if they ohm out ok. They only cost a few cents each, so why risk destroying more expensive components by letting them hang around and go poof.

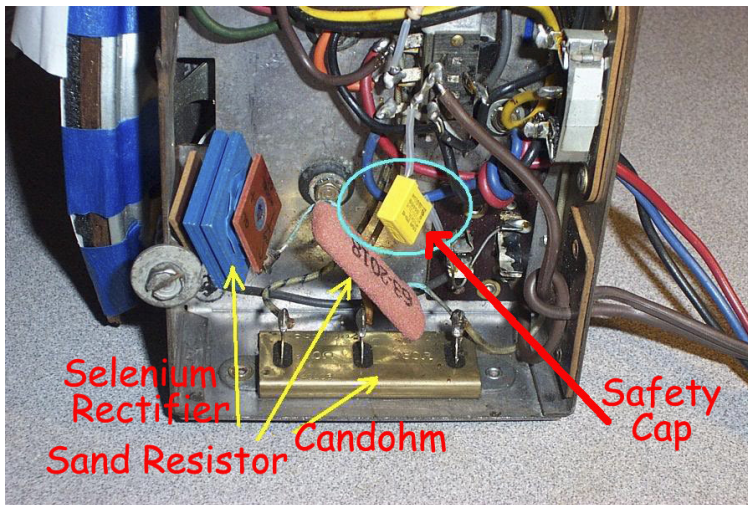
In the photo above, note the safety capacitor (green circle) installed across the AC line.

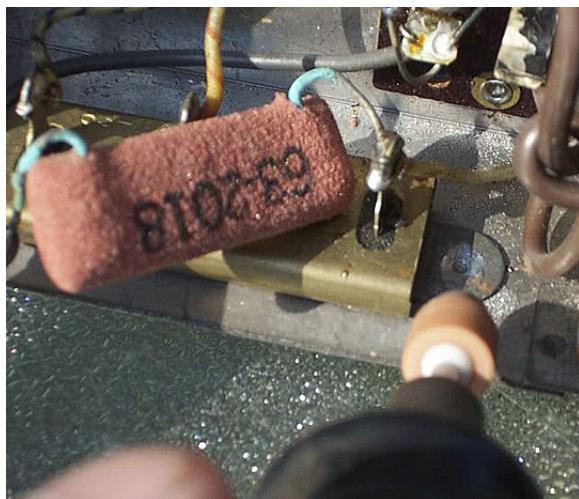
This morning the Dremel Tool and a pointed medium grit stone were used to remove the rivets holding the Candohm resistor to the chassis. That Candohm consists of two 950-ohm, 3-watt resistors. They'll be replaced by two 1k-ohm, 5-watters.

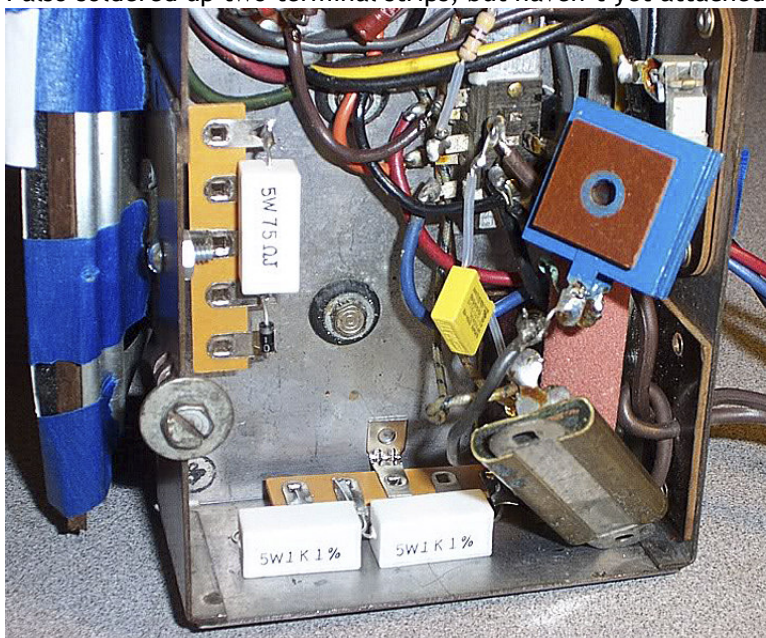
I also soldered up two terminal strips, but haven't yet attached any wires

The strip on the left (screwed to the chassis) has the 1N4007 diode and 75-ohm, five watt resistor. I read that a 75-ohm resistor after the diode will provide the correct filament and plate voltages for this radio, so I decided not to reinvent the wheel. If in the end it proves to be bogus, then I'll pull down the multimeter, fire up the variac and correctly determine the needed resistance. The lower terminal strip holds the resistors which replace the Candohm. It'll be cemented into the chassis, with the resistors against the chassis wall to dissipate heat.

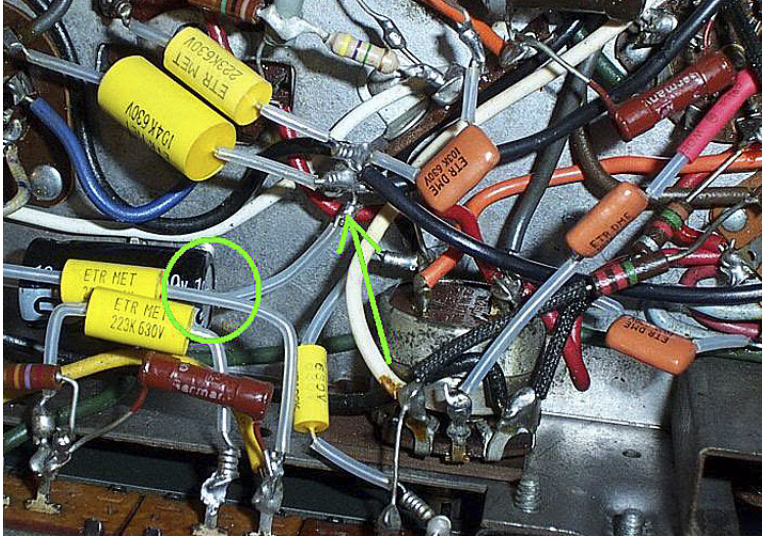
B-minus is the same point where the negative end of the 12uf e-cap (C-21) is connected, also circled in green. Note: I replaced the 12uf with a 10uf.

You'll recall that this radio has a floating ground, so the grounds are not directly connected to the chassis. They're connected to what's called B-minus, which is isolated from the chassis by a capacitor, probably C-15 (.047uf).
