KWM-380

Service Bulletins

AC-3803 CONTROL INTERFACE KIT (641-7150-001)
CONTROL INTERFACE CIRCUIT CARD (638-6910-001)

SERVICE BULLETIN NO 1

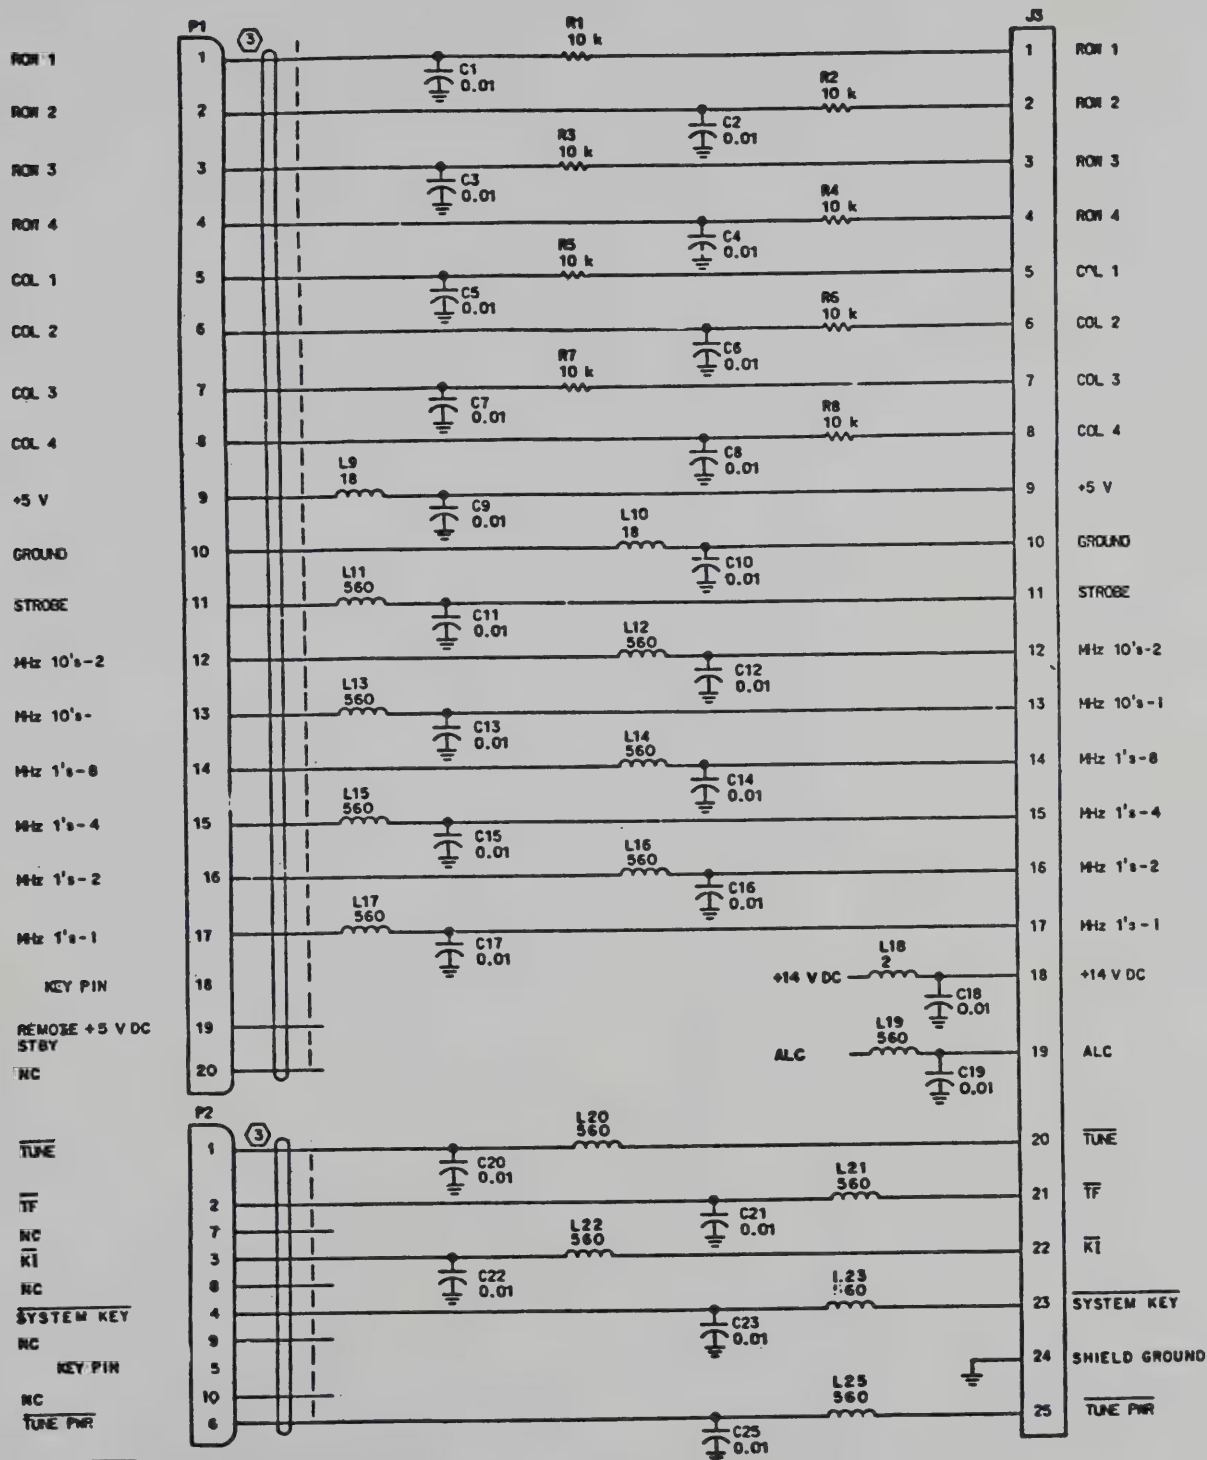
Control Interface Circuit Card Assembly,
Schematic Diagram
Figure 3

Rfi filtering is improved by changing ground paths on the circuit card to increase the effectiveness of the bypass capacitors. More ground paths are provided to reduce inductance. This will help prevent transmitted rf from getting back into the radio causing transmit inhibit condition.

NOTE: Figure 1 is the REV E configuration and figure 2 is the REV H configuration of the circuit card. Refer to figures 1 and 2 for location of components. Refer to figure 3 for a schematic diagram which includes the following changes. Use a 25- to 30-watt soldering iron with a tip designed for use with printed circuits. The tip should be clean to ensure proper melting of the solder prior to component removal or when securing new components to the card. Take care to avoid application of excessive heat.

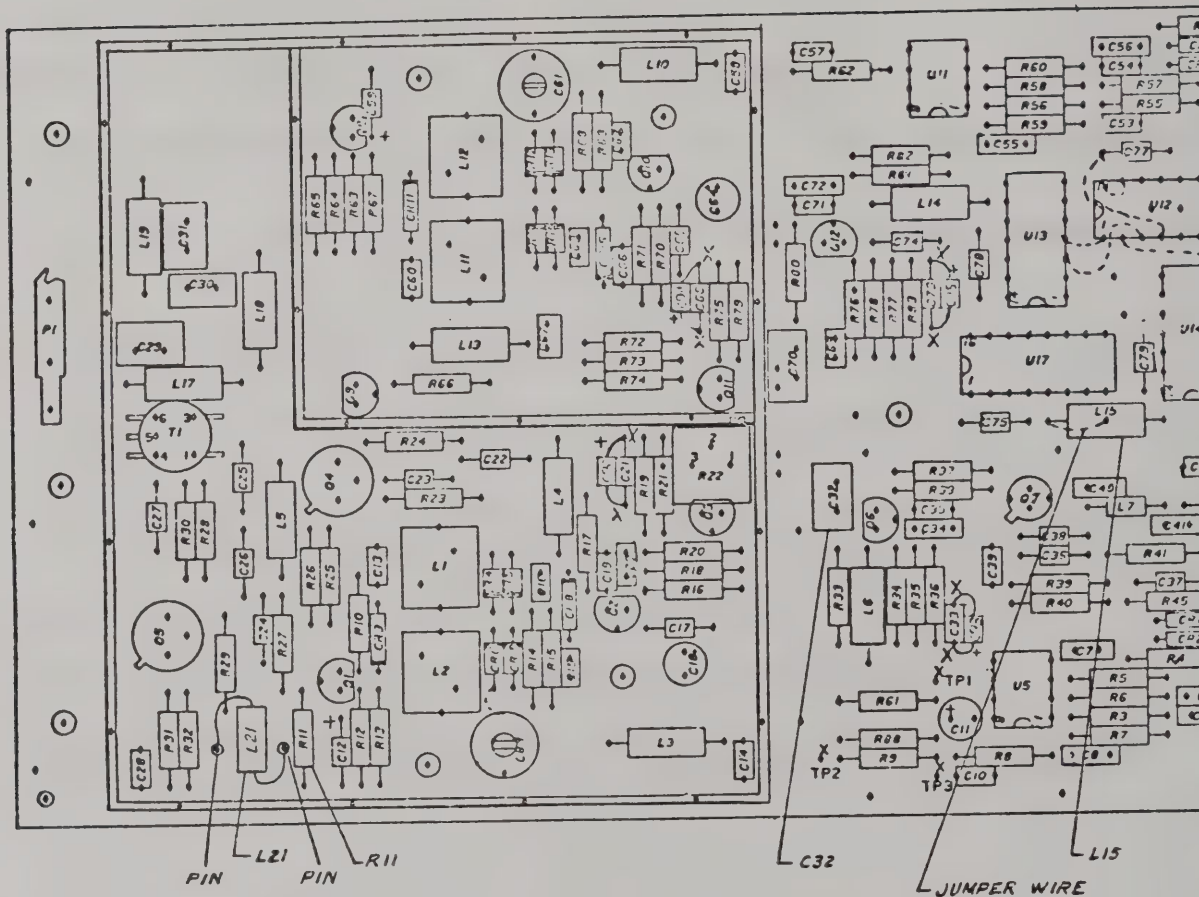
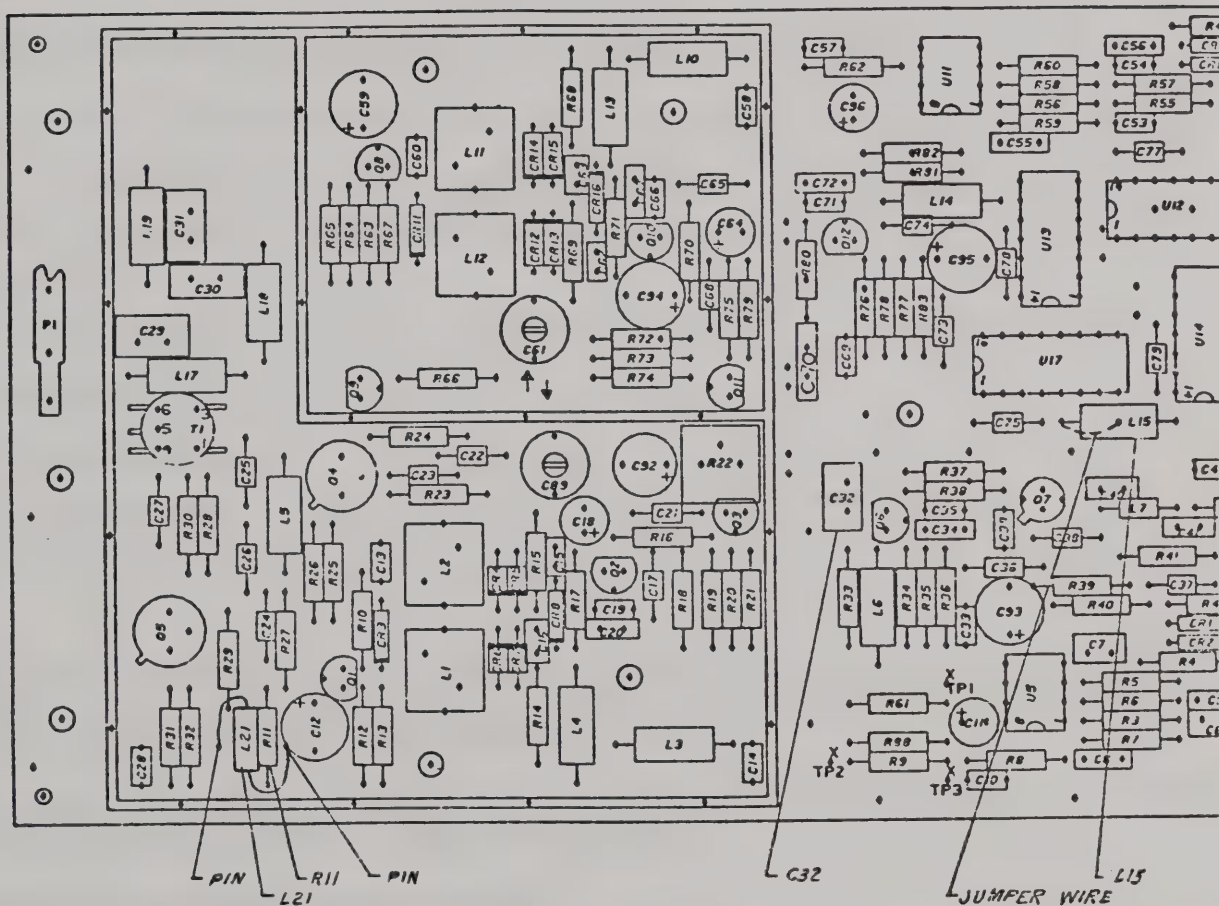
P/O Synthesizer Card A5A1 (638-6916-001)
Figure 1

A frequency warble may occur at certain frequencies in some radios. The warble will usually occur at the top end of each 1 MHz band. The problem has been traced to two integrated circuits on synthesizer variable reference frequency loop A5A2. When U14 and U26 are at the low end of their specified parameters, a low rf input may cause them to miscount.

- I. Connect 4.7- μ H coil (240-1576-000) between the two new pins. Use sleeving (152-2483-000) on L21 leads if needed.
- J. Remove the 27-pF capacitor C32 and replace it with an 18-pF capacitor (913-1098-030).

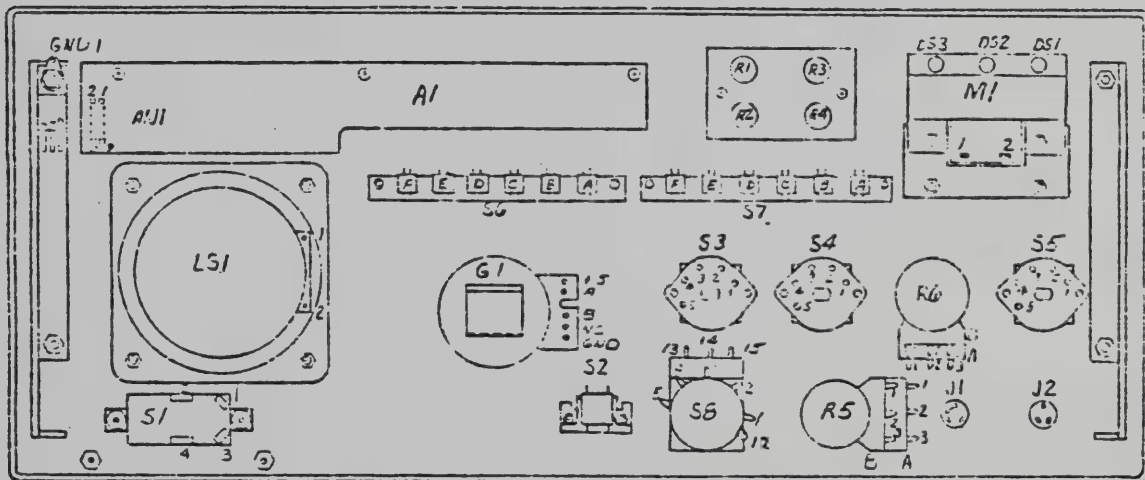
KWM-380/HF-380 Front Panel, Rear View
Figure 1

The purpose of this service bulletin is to correct a transmit hum caused by a ground loop between the front panel and the receiver/exciter card ground plane.

This modification replaces the mic jack (J2) with a jack that has an insulated sleeve contact to break the ground loop.

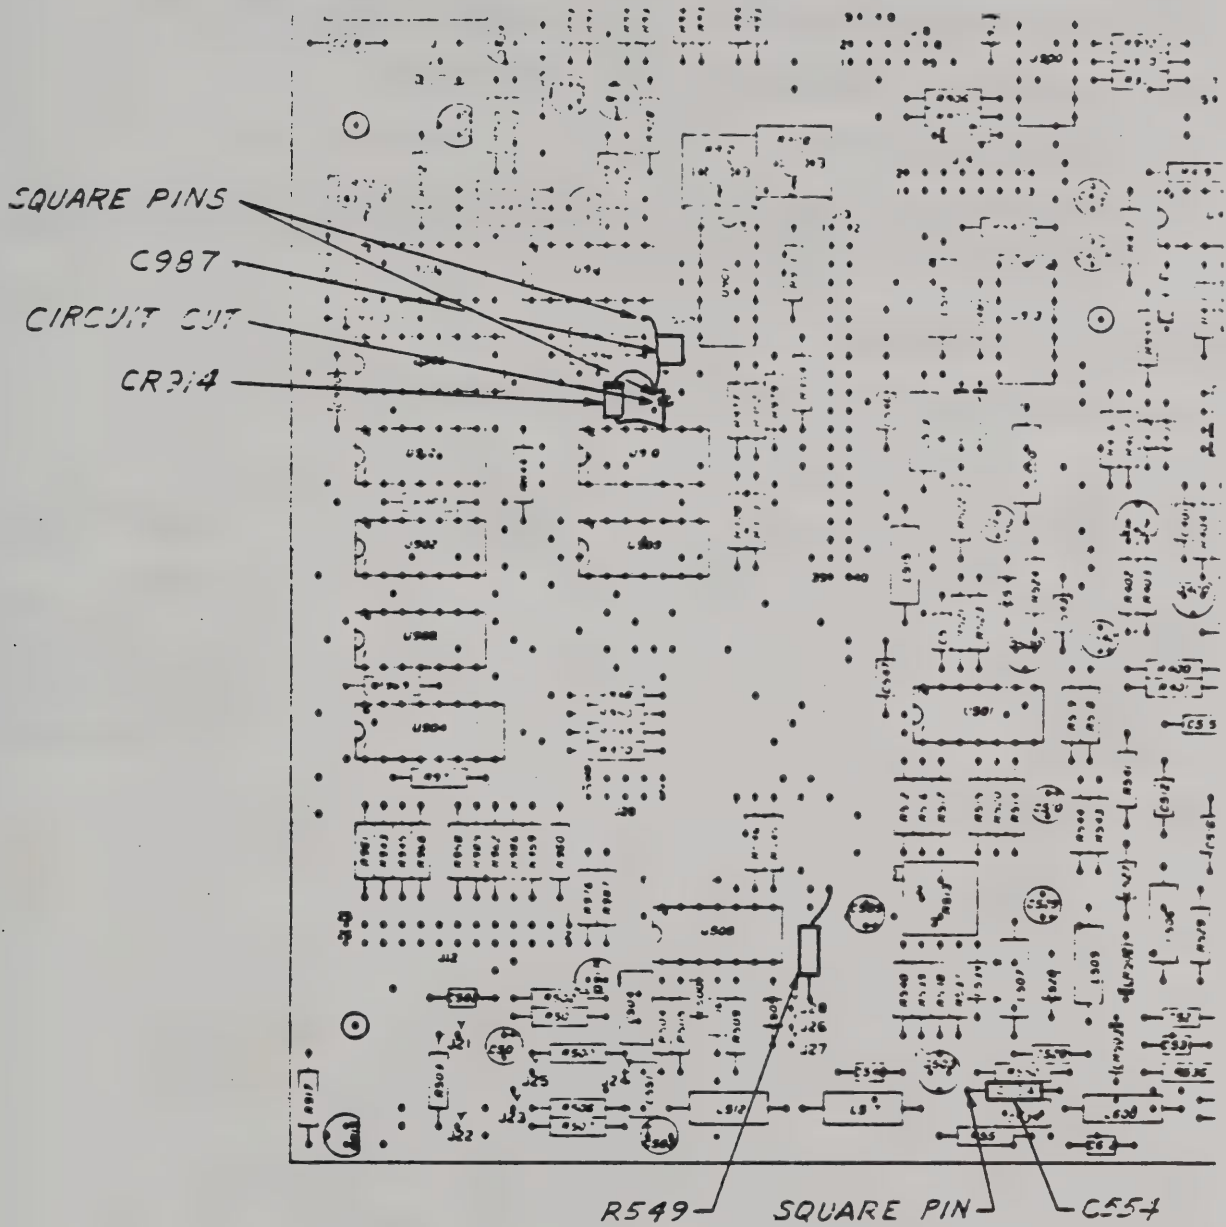
P/O Receiver-Exciter Card A3
Figure 1

The rise and decay time of the cw envelope is less than 1 ms which may cause key clicks to be evident. This modification increases the rise and decay times to a nominal 4 ms. This still produces a hard, but click-free, waveform. This timing may be altered if desired by changing the value of R549. Increase the value to soften the keying, decrease the value to harden the keying.

NOTE: All changes are made to receiver-exciter assembly A3, located on the bottom of the unit. Taking care to not damage adjacent components, these modifications can be made without removing A3 from the chassis. Refer to Receiver-Exciter A3 instructions in the circuit cards section located in the back of the HF-380 and KWM-380 service manuals for location of components to be removed. Refer to figure 1 of this bulletin for location of added components. Refer to figure 2 for a schematic diagram which includes the changes made by this modification.
