# YAESU FP707-FP757

## PSU REPAIR

— "another" design issue

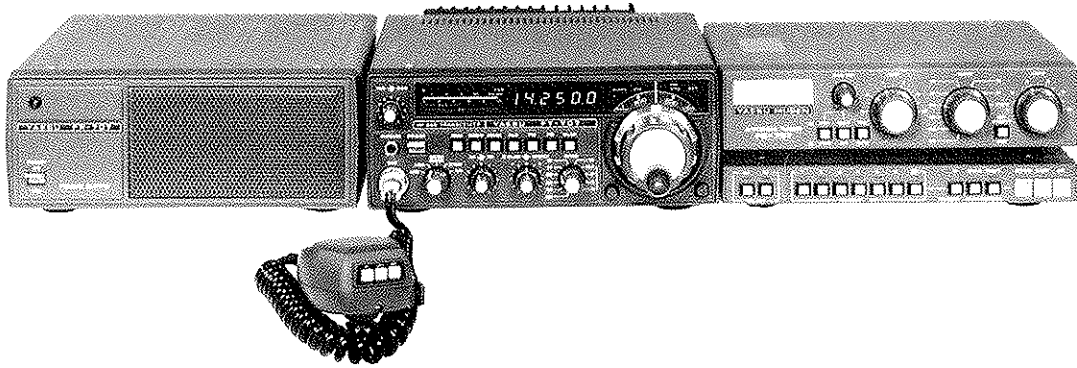
Q103 UNDERSIZED

(SYMPTOM: 22V output  
in stead of 13,8V)

"WAS" 2S4550

↳ fails regularly!

→ do NOT replace by "universal" NPN like BC558

→ too weak, needs HIGH  $I_c$  NPN like BC369

(bend middle collector leg to other side to fit PCB)
